Service Bulletin

RTA-62

22.05.2003

Prevention of Water Carry-Over and Liner Polishing

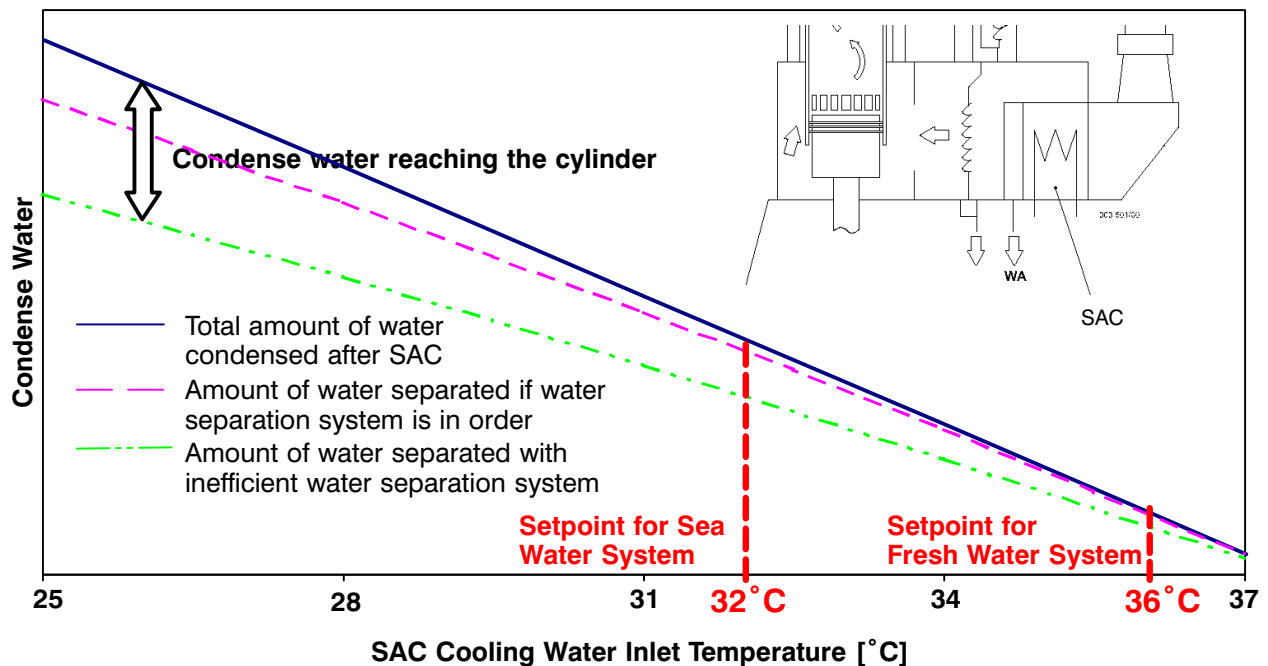
Fig. 1 Condense Water Separation

The figure on the next page illustrates how the amount of condense water reaching the cylinders depends on the cooling water inlet temperature of the scavenge air cooler (SAC).

As preventive measure against water carry-over and the possible consequential damages, the water inlet temperature of the scavenge air coolers should be set to the value for tropical conditions as specified in the Operating Manual:

- For central cooling systems 36 °C (LT)
- For sea-water cooling systems 32 °C

These values must be set at the controller of the automatic temperature control valve of the corresponding cooling water circuit for all load conditions. With these settings and at full load T_{scav} should be around 48 °C.
