Field Experience

**L27/38 propulsion engine powering
M/V MARK AMAY**

L27/38 propulsion engine powering M/V MARK AMAY

The following paper describes our field experience with MAN Diesel four-stroke propulsion engine type, L27/38, powering the Irish fishing vessel M/V MARK AMAY, built at Karstensens Shipyard in Skagen, Denmark.

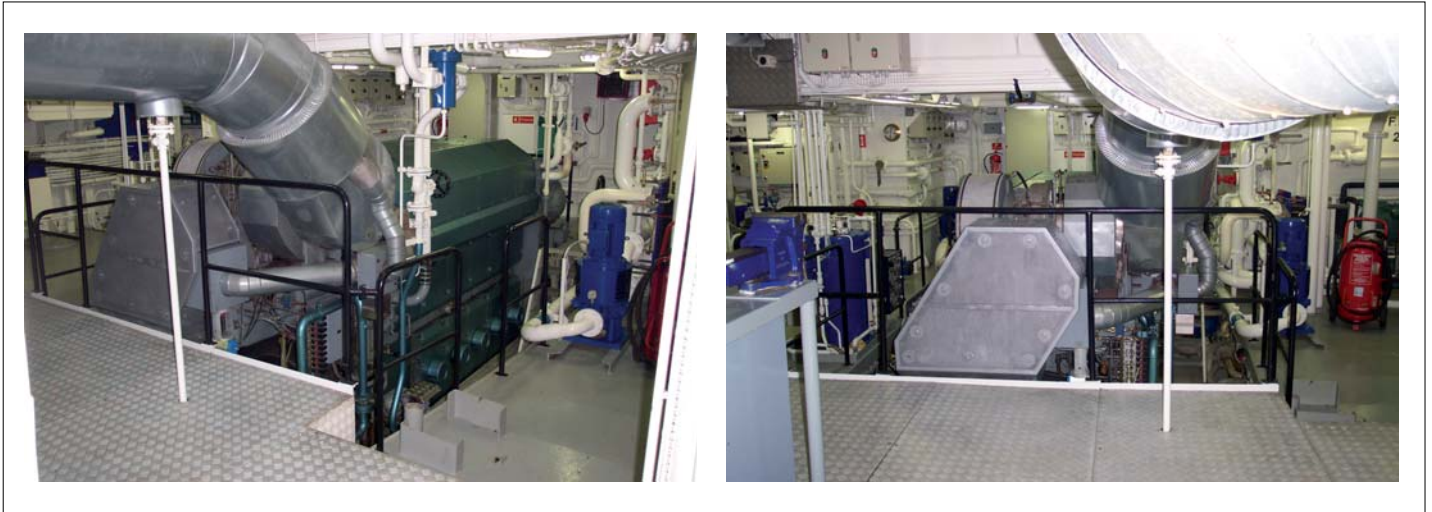
Figs. 6 and 7 M/V MARK AMAY engine room – very clean and well maintained

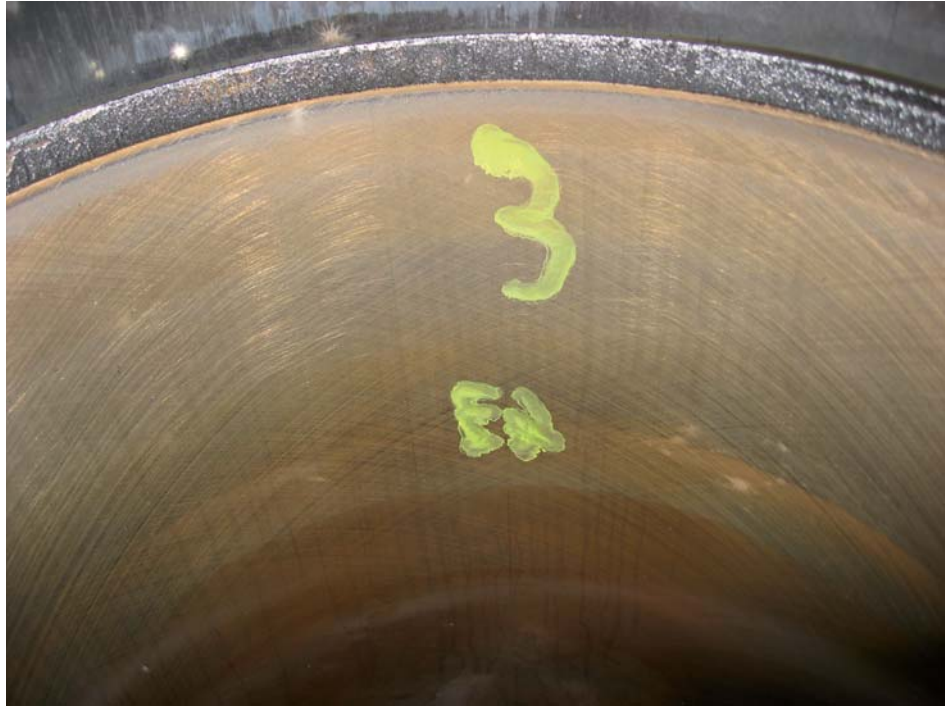
The liners looked fine after 26,300 hrs of operation and the honing marks were visible on the entire liner surface.

Calculating the wear rate of the liners, we normally used the key figures by calculating the wear rate in [$\mu\text{m}/1,000$ hrs operation] and in this case we obtained an exceptionally low wear rate of 2 [$\mu\text{m}/1,000$ hrs].

Fig. 9: Liner no. 4 in the upper TDC point after 26,300 hrs of operation

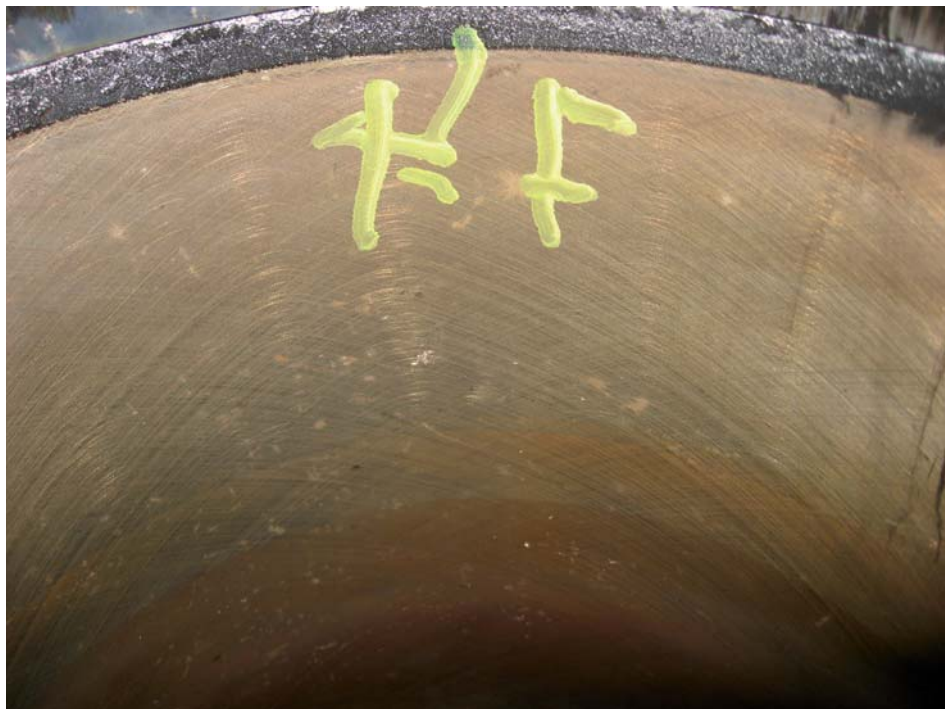
Fig. 10: Liner no. 3 exhaust side in the upper TDC point after 26,300 hrs of operation

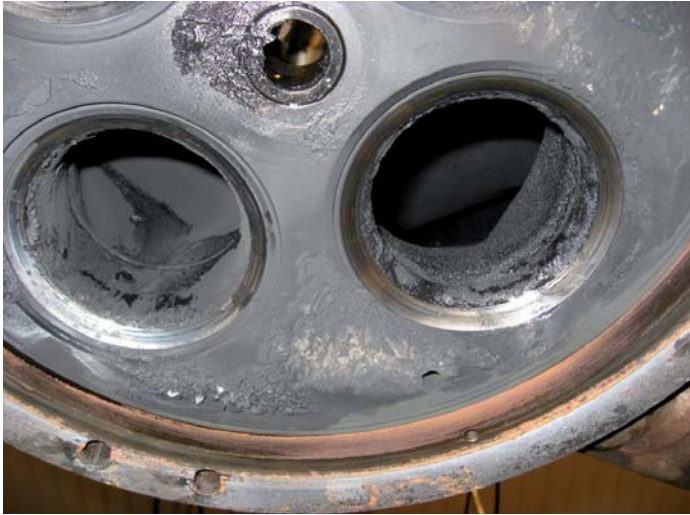
Fig. 11: Cylinder head inlet – and exhaust ring. Coke deposit limited after 26,300 hrs of operation

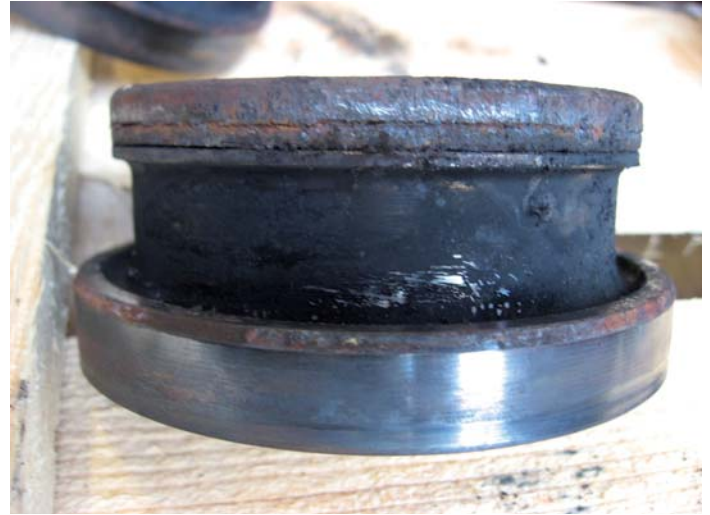
Fig. 12: Exhaust seat ring – corrosion-damaged due to inadequate cooling water inhibitor

All cylinder heads were dismantled for cleaning and repair. Components such as valves, valve seat rings, valve rotators, valve bridges rocker arm shaft and bearing bushes were overall in excellent condition after a total of 46,300 hrs. However, at the end of the repair, we have only renewed 2 inlet valves and 12 exhaust valve seat rings. The exhaust valve seat rings were replaced because of minor water leakages around the 2 seat rings, due to an improper water inhibitor added to the HT water.

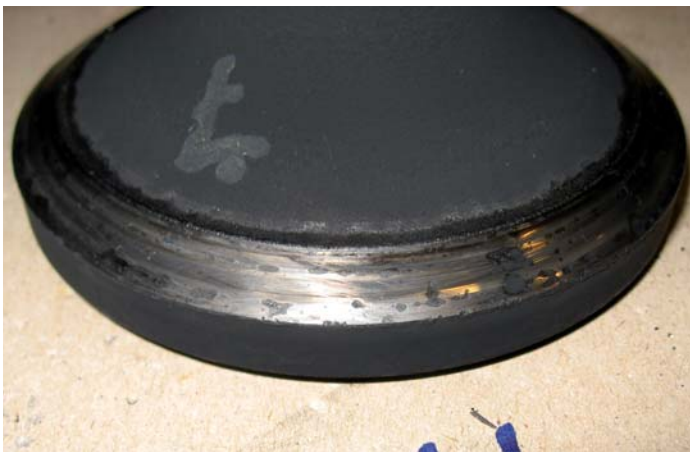
Fig. 13: Exhaust valve after 46,300 hrs of operation

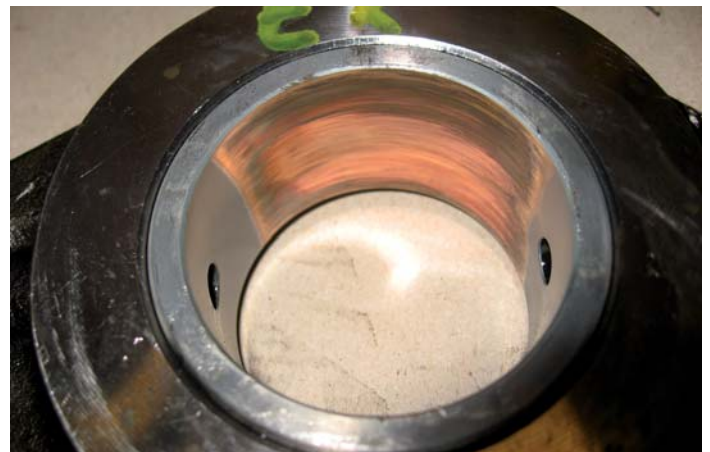
Fig. 14: Exhaust rocker arm bush after 46,300 hrs of operation. Can continue operation

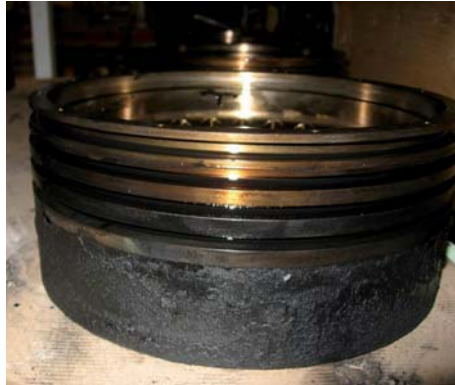
Fig. 15: Piston top crown in good condition after 26,300 hrs of operation since the last withdrawal

Owing to MAN Diesel's continuous development philosophy, the piston top and the piston ring design have been modified, since the Mark Amay engine was built. We decided to replace all piston tops, despite of the fact that the wear rate of piston ring grooves could have continued operation. The benefit regarding better "long time" lube oil control and less deposits in the ring

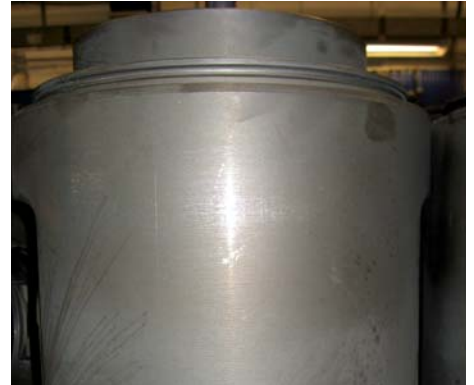
completely free from glazed areas in the running layer (Molycote threaded) and the lower part of the piston continued operation without any repair.

Fig. 16: Piston skirt can continue service after reconditioning of the piston steel top

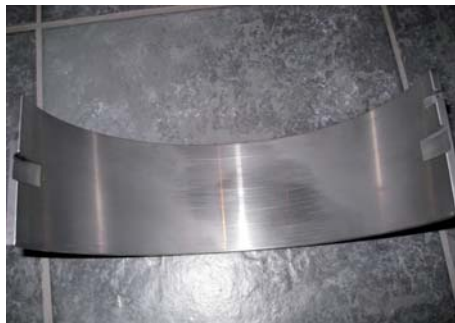
Fig. 17: Main bearing no. 1 after 46,300 hrs of operation

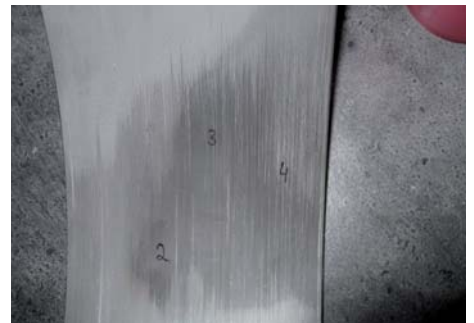
Fig. 18: Close-up photo of main bearing no. 1

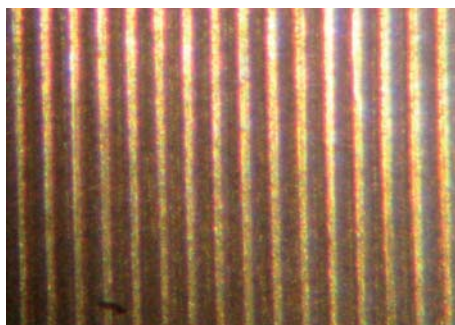
Fig. 19: Main bearing no. 1 after a blow-up (30 times) Miba "Rillenlager" structure in good condition

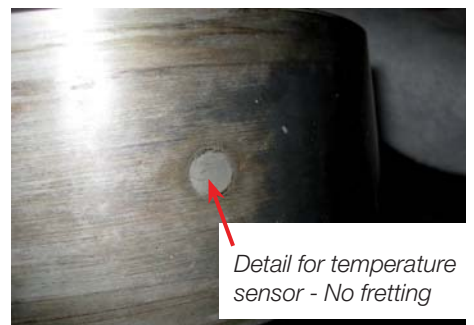
Fig. 20: Main bearing no. 1 - Back side of lower main bearing shell

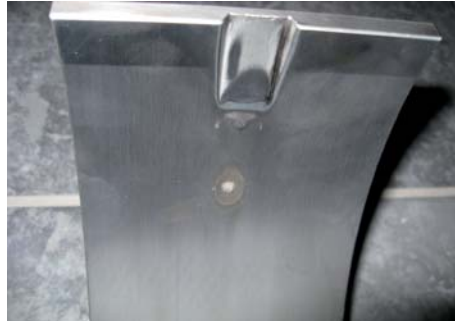
Fig. 21: Main bearing no. 2 - Cavitations mark visible

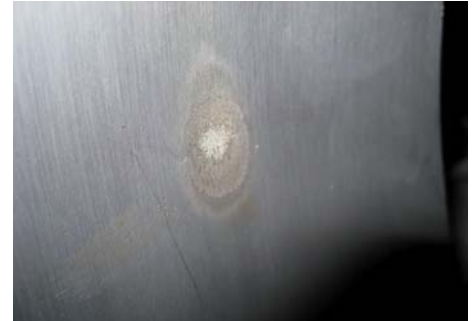
Fig. 22: Main bearing no. 2 – Close-up of the cavitation marks. Visible at the ends of the oil grooves

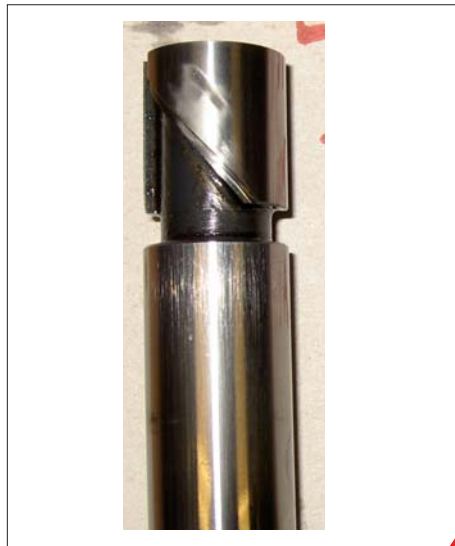
- Minor cavitation marks on the plunger top
- Scratch mark in lengthwise direction on the lower part of the piston
- Severe cavitations at the inlet holes at low pressure side

The above pump element was ready to be renewed and it looked like the TBO for the pump was reached after 36,000 running hrs at MGO, which more than fulfil our guidelines for lifetime.

Fig. 23: Plunger with cavitation

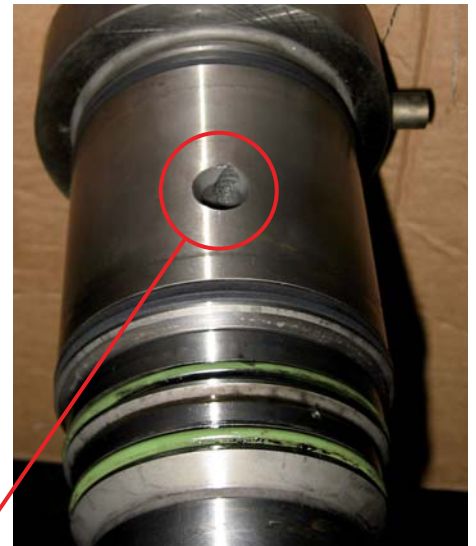
Fig. 24: Cavitation marks at the inlet bore low pressure side

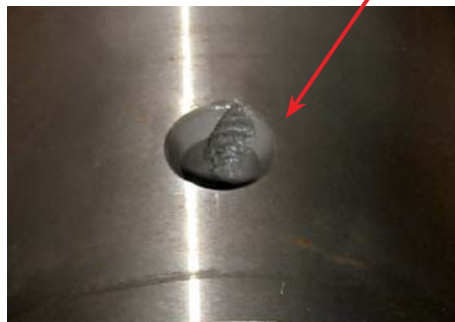
Fig. 25: Detail with inlet bore

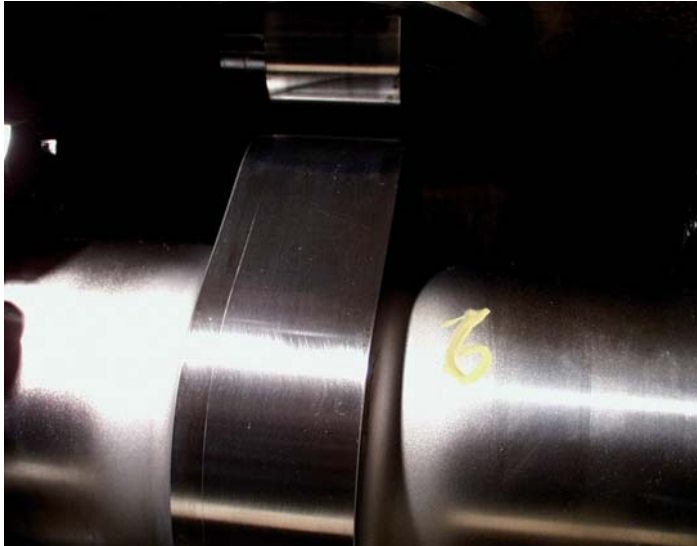
Fig. 26 Fuel cam no. 6

All other inspections during the general overhaul did not reveal any adverse conditions. Special attention was paid to cams, rollers, crankshaft journals and the MAN Diesel turbocharger type NR24/S. The cams and rollers had almost the same appearance, as when the engine left the testbed. A crankshaft check for possible journal wear was carried out and the journals were found to be in excellent condition. The vibration damper (sleeve spring damper type) on the front end of the crankshaft was checked, and nothing irregular was found.
