Welcome to the fourth issue of *Technical Matters*, a Lloyd's Register publication containing case studies covering technical issues and their solutions.

TECHNICAL MATTERS

June 2009

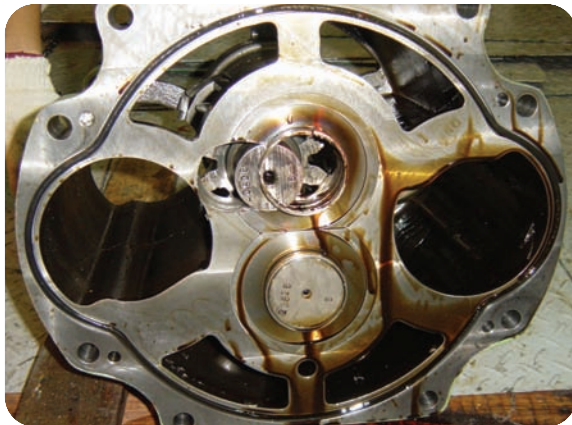
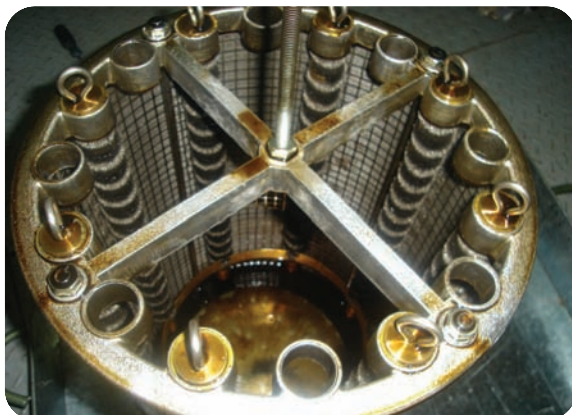
A number of problems were identified, including:

- aerated oil being delivered to the pump suction pipes due to the pump suction and engine discharge pipes being in close proximity;
- the accumulation of air in the suction system due to pipe geometry;
- contamination of the lubricating oil with fine metal particles possibly extending back to original construction.

On completion of the sea trial, both of the lubricating oil pumps were removed and dismantled for inspection. The pumps were found to be in as-new conditions. It was concluded that the circumstances that caused the previous failures had been rectified and no further problems have been reported by the owner.

An extensive range of modifications were made to the sump tank and the off-engine lubricating oil pipework system. A thorough cleaning of the entire system was also carried out to remove all metal debris.

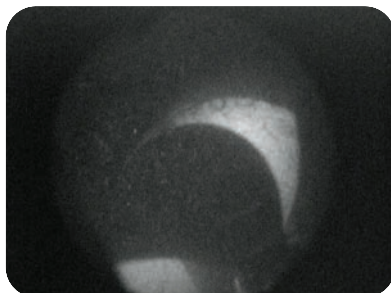
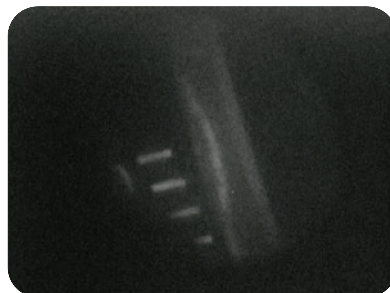
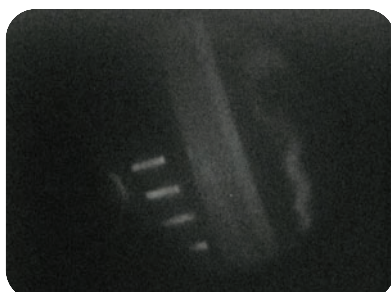
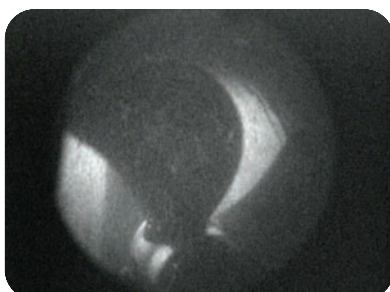
Borescope observations of flow at the duct exit plane showed variable length sections of a strong cavitating tip vortex emerging from the duct at shaft rate. Tip vortex cavitation structures were also observed within the duct, some disintegrating. Audio and video recordings showed a correspondence between the dominant collapse of the tip vortex emerging from the duct.

This was the first known case of a once per revolution broadband noise source which was not from a "singing propeller". It was concluded that dimensional variations on the propeller and duct may have led to the formation of the strong cavitating vortex. Recommendations were made to survey the other ships and to pay close attention to the blade inspection process, assembly and installation inside the ducts.

Palliative solutions included injecting air into the upper duct region, applying acoustic damping materials and insulating the stairwell adjacent to the cabins experiencing high noise levels. Ultimately the problem was tackled at source and a redesigned propeller was fitted.

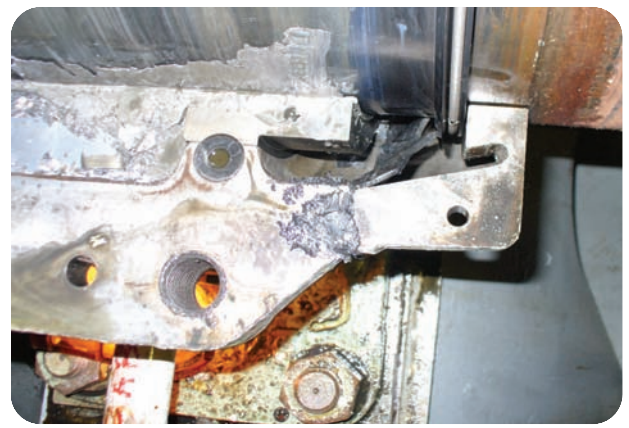
During a partially laden voyage a direct drive diesel powered Chemical Tanker suffered a severe failure of the intermediate shaft pedestal bearing. Significant wiping damage occurred to the bearing white metal surface requiring the ship to be towed to port for repair.

Following the failure bearing loads and shaft deflections were measured using the jack-up technique. The results revealed an unsatisfactory distribution of

load along the shafting system length. In particular it was found that the forward sternbush and the second aft engine bearing had insufficient downwards load. The second aft engine main bearing was considered to be at risk of fatigue damage.

Calculations revealed that the scope for improvement of the alignment conditions by adjustment of the intermediate bearing was limited. Loading of the engine second aft main bearing by fitting an upwards offset bearing shell was therefore recommended. Such adjustment would improve the loading on the engine bearing but would have negligible effect at the forward sternbush.

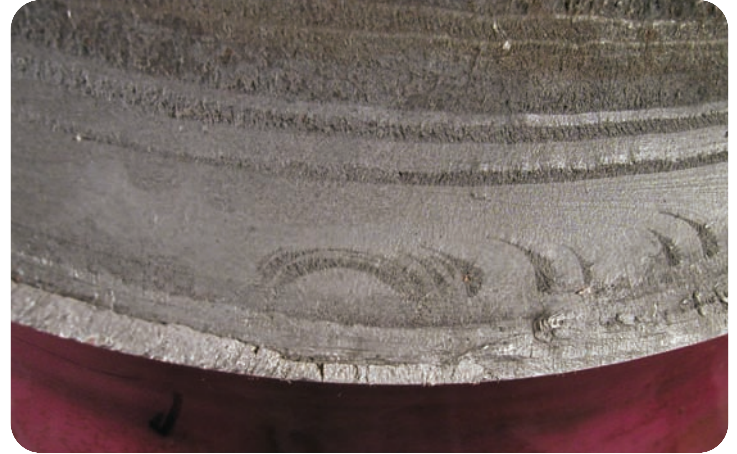
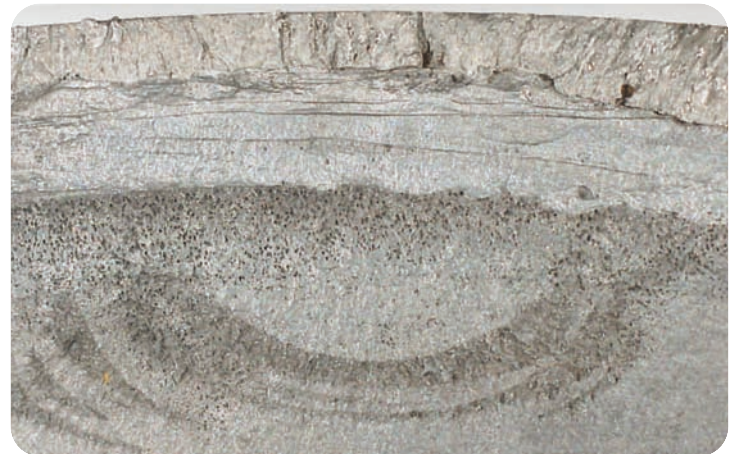
By examining the remaining part of the fatigued stabiliser stock at the Lloyd's Register Materials and NDE Laboratory it was found that a fatigue crack had grown from a single initiation point, 5 mm below the shaft surface, in the fusion zone between a weld and the base material. Welded regions often show characteristic non-uniformities and inclusions at the base material interface. It was also found that no heat treatment had been undertaken to eliminate residual stresses. These residual stresses can often encourage crack growth.

shaft due to roll of the ship in service. The low factor of safety was apparent from the fatigue pattern as the fatigue crack had propagated for only 15% of the shaft diameter before rapid brittle fracture finally occurred.

During the initial stages of crack growth there were three distinct bands of relatively slow propagation interspersed with two narrow bands of more rapid propagation. These changes in crack growth rate indicated significant changes in service loading, such as loading induced by especially rough sea conditions.

Recommendations were made that the stabiliser stocks on sister vessels should be examined visually and by non-destructive testing for the presence of cracks. Recommendations were also given to fitting shafts with an increased operating margin against imposed bending loads.

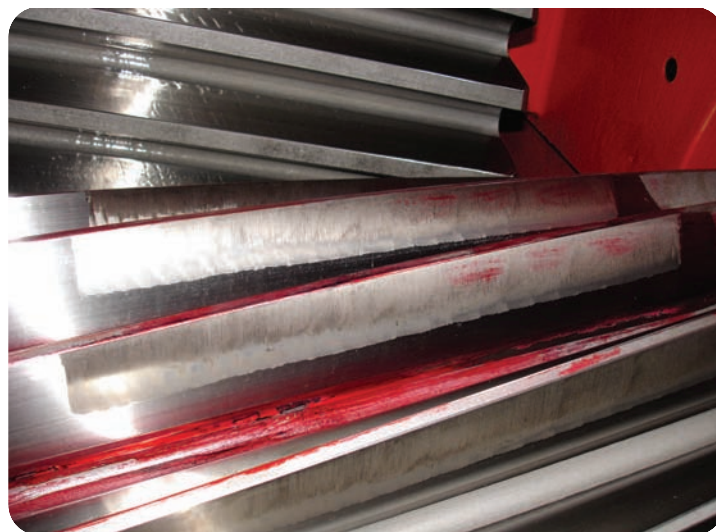
Severe scuffing damage occurred on the teeth of the two input pinions and main wheel of the main propulsion gearing during trials of a newly built diesel electric LNG carrier. The propulsion system consists of twin electric motors driving a single output main propulsion shaft and fixed pitch propeller through single reduction, single-helix gears. Lloyd's Register Technical Investigations (TI) was asked to attend onboard at the newbuilding yard to inspect the tooth flank damage and assist with the failure investigation.

The scuffing damage was due to a breakdown of the elasto-hydrodynamic oil film which should normally be present between mating gear teeth. The breakdown resulted from a combination of the selection of the pinion gear tooth-end design and the rapid rate of torque input to the pinion gears from the electric propulsion motors. It was considered likely that the damage was initiated at the starboard mesh and then transferred to the port mesh in way of the main wheel.

The damaged pinion gears were returned to the gearing manufacturer for remedial

machining including design modifications to the gear tooth flank. The main wheel tooth flanks were polished in-situ.

Following repair, the reduction gearing successfully completed sea trials. This was achieved by modifying the pinions helix correction and end relief. The propulsion electric motor speed-torque characteristics had also been modified to reduce the initial rate of torque delivery to the pinion gears.

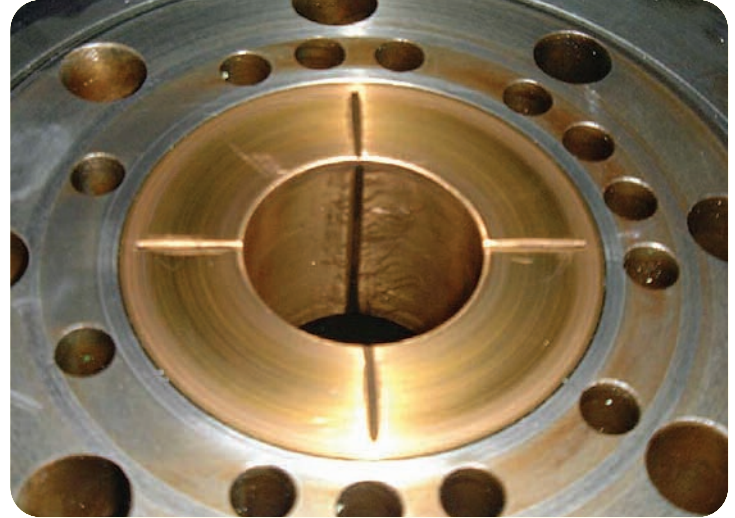
- the air start valves fitted to the engine had air leaks in all valves in way of the valve seat:
- the starting air manifold and the air inlet pipes had an internal coating of a black oily/sooty substance (consistent with the physical characteristics often found after an explosion). Oil sludge deposits were removed from the air start manifold and sent for analysis, proving that the source of the oil contamination was the main air compressor lubricating oil:

- during engine operation the air start manifold contained a large amount of mist and smoke.

It was found that the air distributor, which provides the timing for opening the air start valves, was worn excessively by the ingress of hard foreign objects. The wear allowed air to enter unintended air start pilot lines, opening both correct and incorrect air start valves. Firing from the main engine cylinder had then allowed an ignition source into the air start

The system was repaired by replacement of the air distribution system along with machining and lapping of the air start valve seat. The air start manifold, piping and associated machinery were also thoroughly cleaned. Recommendations were also made to overhaul the main air compressor lubrication system, to prevent the air start manifold becoming contaminated with lubricating oil.

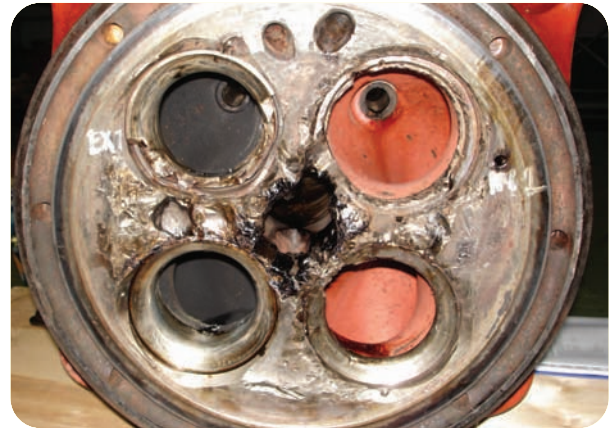
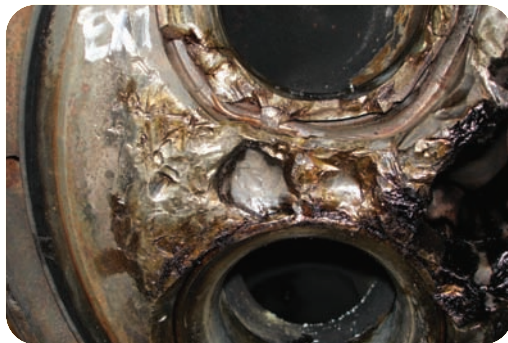
The primary cause of damage to the first cylinder head, valve and running gear was a detached inlet valve head (tulip), which had become separated as a result of the development of a fatigue crack from multiple origins associated with a bend in the valve spindle.

Fibrous debris was found in the valve bridge oil-way which restricted the oil flow to the sliding surfaces of the valve bridge piece and valve guide post. Galling and seizure damage were identified on the components. This damage had impaired the valve motion and allowed contact with the head of the piston.

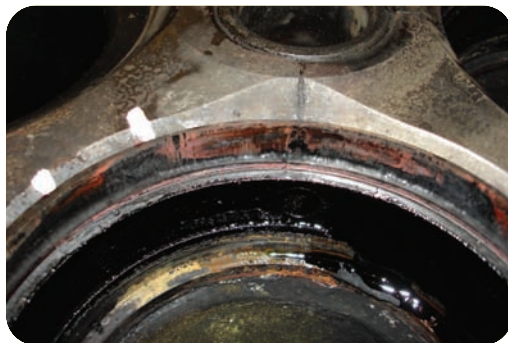
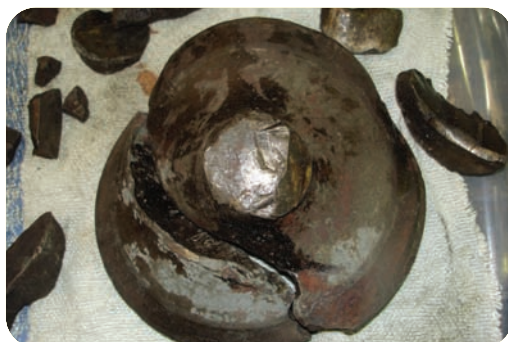
In the second incident, cracking was found on the cylinder head between the exhaust valve seat and injector sleeve bore. The cracking was characteristic of an increase in the thermal stresses between these sections.

The cylinder head cooling water spaces were contaminated with a black oily substance. The substance was identified using gas chromatography analysis to be heavy fuel oil. The coating of oil covering the water spaces impaired the heat transfer to the water, increasing both the temperature gradient and stresses in the thin hottest sections of the flame deck.
