To Owners and Operators of
MAN B&W Holeby Four-Stroke Diesel Engines,
Type: All Types

SERVICE LETTER

SL97-350/ESC
November 1997

**Subject: Damage of Main Bearings on Rigidly Mounted Auxiliary Engines
caused by External Vibrations from the Hull Structure**

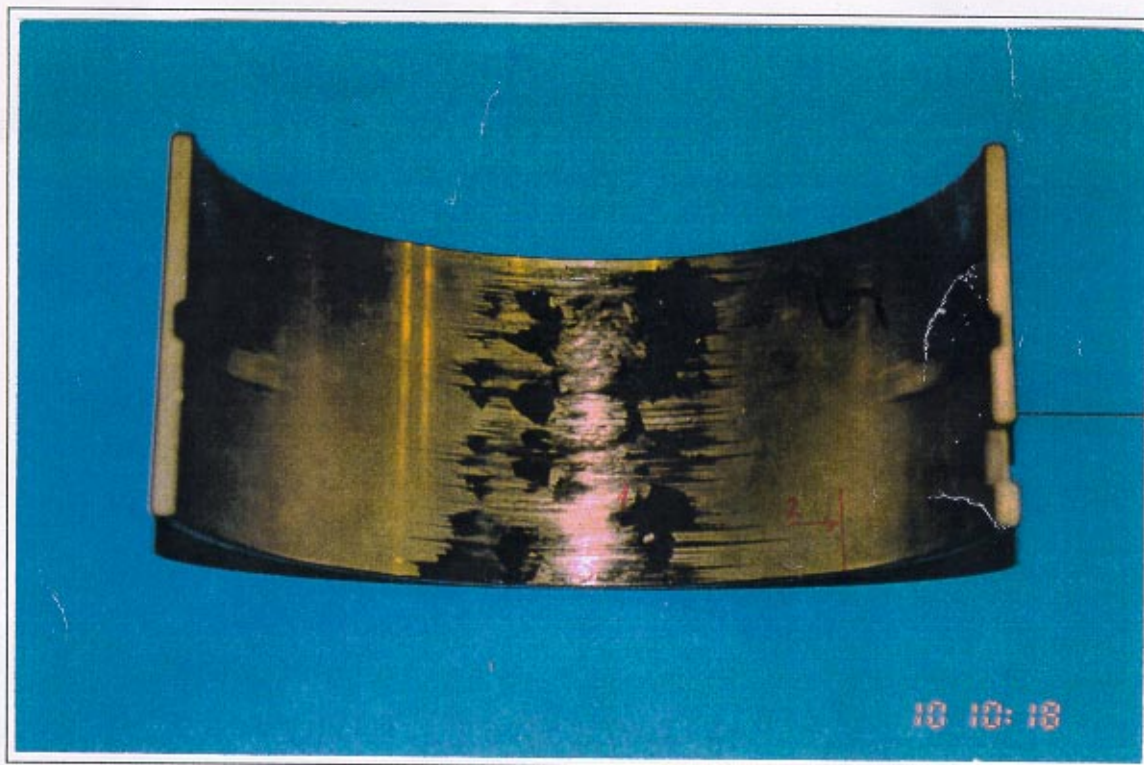
Lately, the MAN B&W Diesel A/S, Holeby Service Department has seen several examples of main bearings with an abnormality in the form of a black coating on the entire contact surface between bearing and bearing journal, see enclosed Technical Information No 305-S6/610-S5.

Analysis of a damaged main bearing has shown the black coating to be lead oxide caused by static fretting. Measurements have shown the coating to be 6 to 7 times harder than the bearing material.

Fig. 1. General view

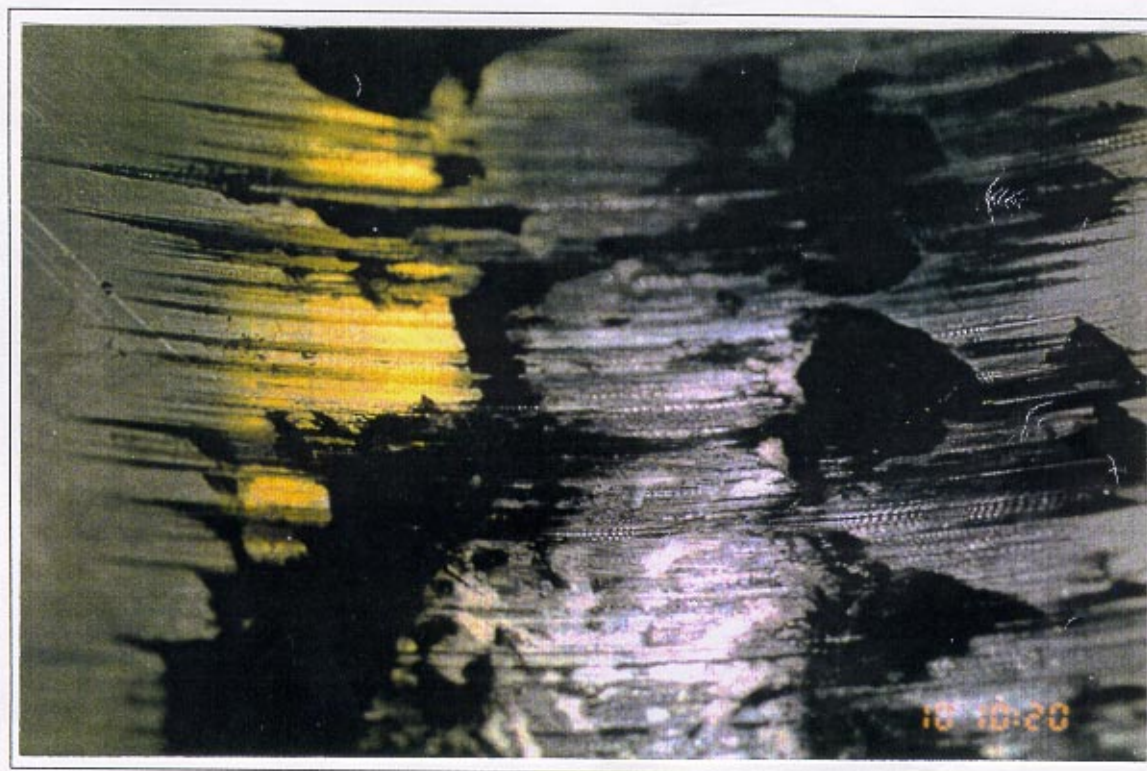
Such a coating destroys the main bearing surface and results in increased wear of the main bearing journal.

Static fretting occurs during engine standstill, as a consequence of the movement of the main bearings in relation to the crankshaft, caused by external vibrations transmitted to the engine from the hull structure.

We have discovered that the high vibration level is the result of insufficient support of the deck on which the auxiliary engines are mounted. This combined with the fact that the engines are rigidly mounted causes vibrations from the hull to be transmitted to the auxiliary engines.

Fig. 2. Blackened and pitted bore

Finding a solution to this problem requires involvement of a naval architect to make proposals for a change of the deck / platform support.

Continuous operation of the **prelubricating** oil pump during engine standstill may result in certain improvement, although with limited effect.

Alternatively the engines could be mounted resiliently, to which end MAN B&W Diesel A/S, **Holeby** may be of assistance. However, it is important to bear in mind that the necessary changes will be extensive as all pipe connections etc. must be flexible, and the base frame has to be replaced. Due to the necessity in changing the base frame the foundation has to be modified.
