Field experience with the MWH ReliaValve with Sentry Rotator: a 2-Stroke exhaust valve with demonstrated time between overhauls (TBO) of over 5 years.

INTRODUCTION

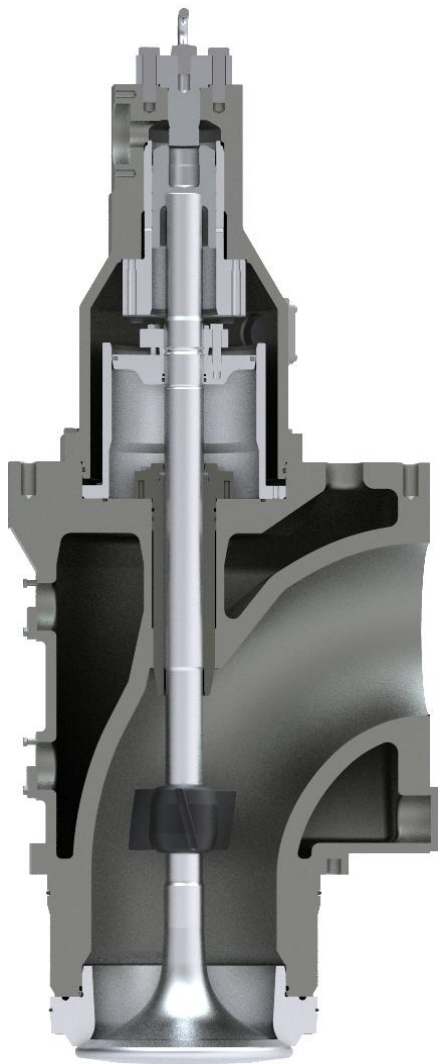
Figure 1: Typical 2-stroke engine exhaust valve

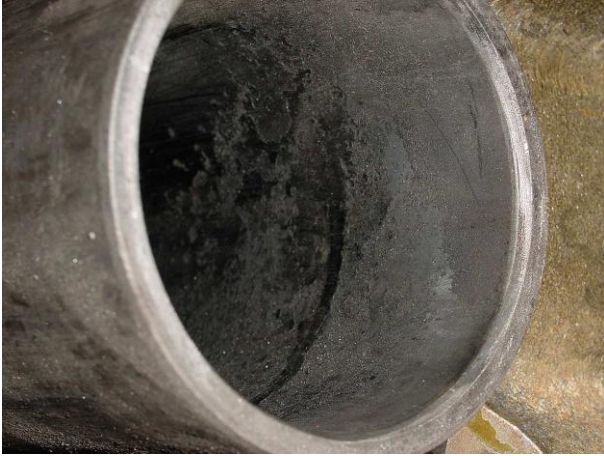
Figure 2: Valve guide with evidence of adhesion and abrasive wear [6].

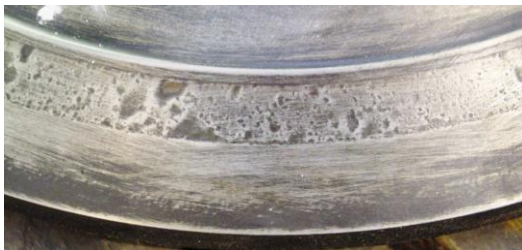
Figure 3: Valve spindle with extensive evidence of dent marks [6].

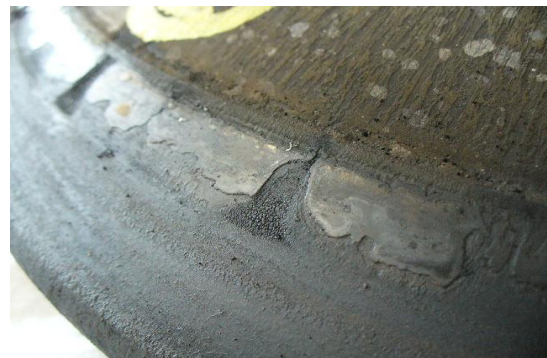
Figure 4: Valve spindle with extensive "glassy-deposits" and beginning of blow-byes.

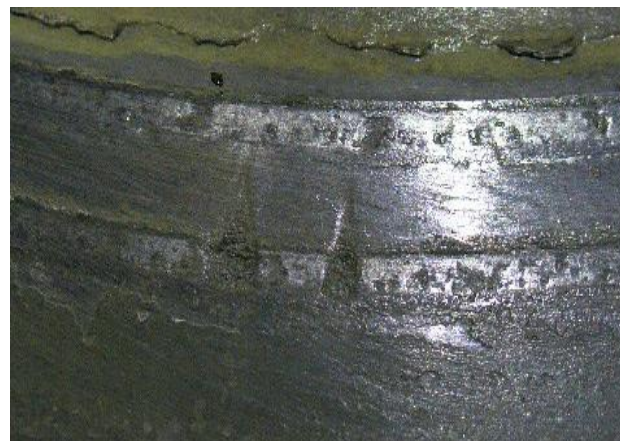
Figure 5: Valve spindle with extensive dentmarks and beginning of blow-byes (W-type geometry of bottom piece).

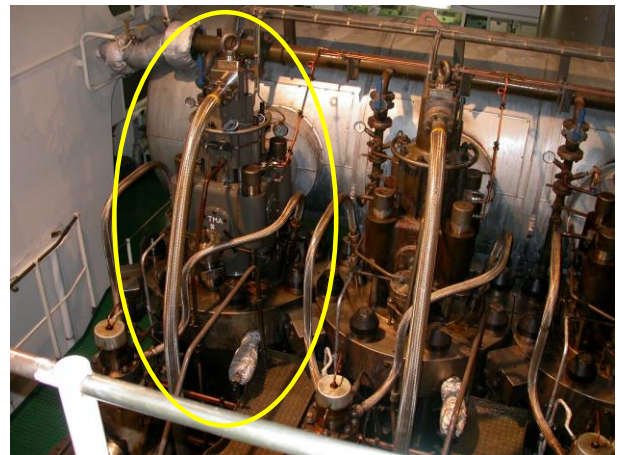
Figure 9: Cylinder #1 of the MAN-B&W 7L70MC engine on the "MV Libra Buenos Aires / CMA CGM Bahia" [6].

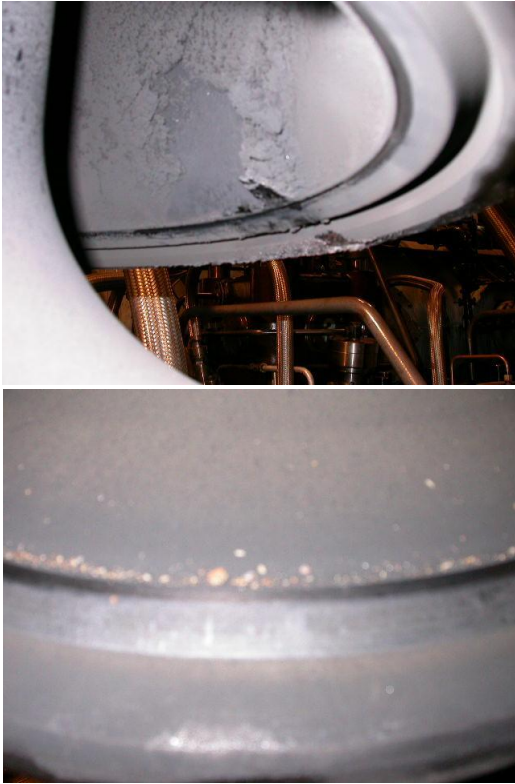
Figure 10: Photographs of the valve spindle and seat ring surfaces after 1,000 hours [6].

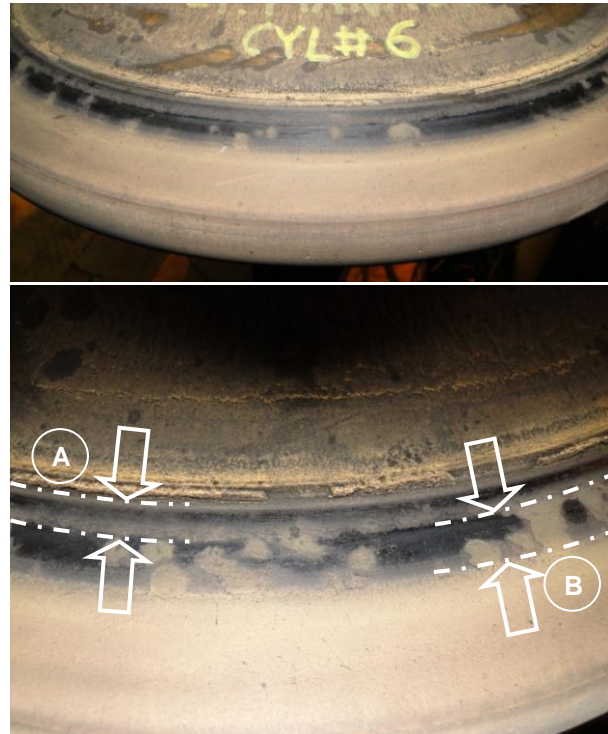
Figure 20: Valve spindle seat with removed glassy-deposits (chamber type geometrie of bottom piece with modified seat angle for higher seating pressure).
