# Typical wear mechanism of 2 stroke exhaust valves

Extend Component Life and Time Between Engine Overhauls.

**MÄRKISCHES WERK**

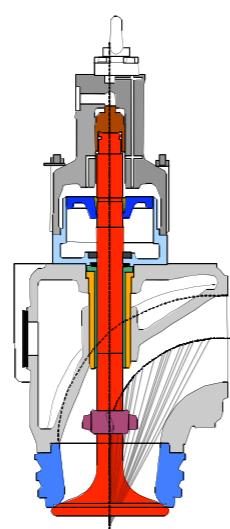
Figure 01:  
Main components of an exhaust valve

The design of the exhaust valves of all three engine builders are different in details, but the general function is the same, see figure-01. The main components of MC, RTA and UEC are:

- Valve drive or hydraulic actuator
- Air cylinder
- Valve housing
- Valve guide
- Valve spindle
- Bottom piece or seat ring

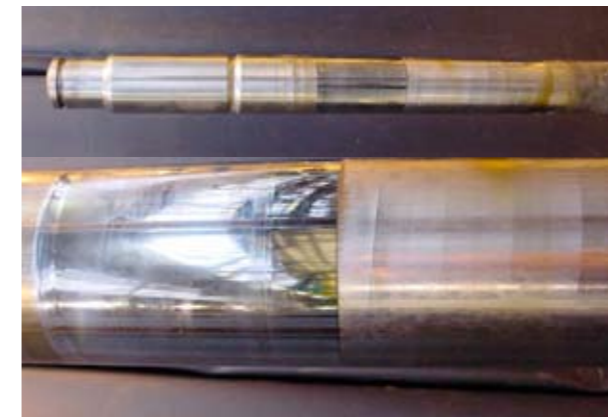
Adhesion and abrasive wear is very often found in the stem sealing area of hard chromed, MC valve spindles (see figure 02). Usually the limit of this stem diameter is reached after 12,000 - 18,000 hrs. MC valve spindles with HVOF-stem coating, as well as RTA- and UEC valve spindles with hard-chromed stems, reach a TBO (time between overhaul) of 24,000 - 36,000 hrs.

Figure 02:  
Physical adhesion and abrasive wear of a hard-chromed valve spindle (MC-type after 15,000 hrs)

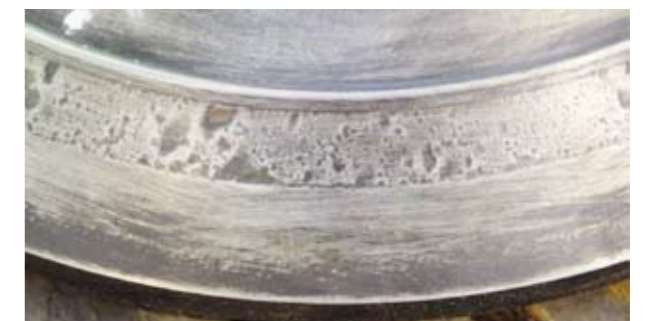
Together with high seat pressure and a higher seat hardness of the bottom piece, the MC-type shows the highest probability and intensity of dent marks with TBOs of 6,000-18,000 hrs (see figure 03). The seats of RTA- and UEC-types require overhauls after 12,000 - 36,000 hrs.

Figure 03:  
Typical dent marks of the seat of a valve spindle (MC60-type Nimonic after 8,300 hrs)

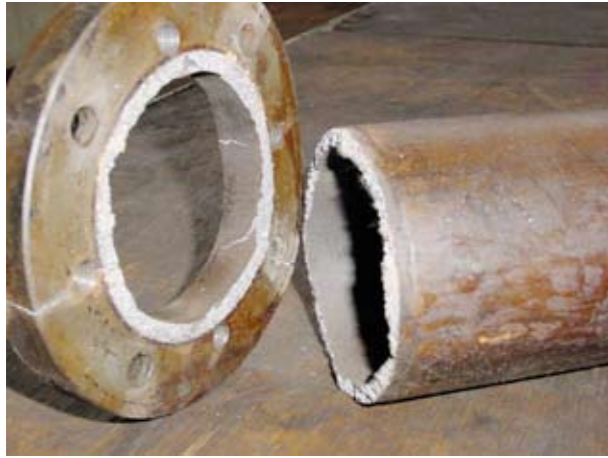
To disassemble exhaust valves, hydraulic power is usually necessary to remove the valve spindle from the valve guide. In some cases the sticking of the valve spindle is so extreme that the valve guide breaks during the operation (see figure 04a and 04b).

Figure 04a: Breakage of the valve guide during valve spindle disassembling

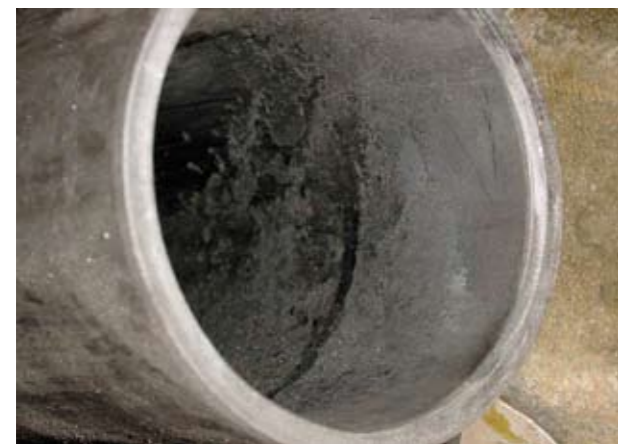
Depending on the design of the valve guide, its inner diameter will display more or less deposit buildup. Exhaust gas enters into the clearance between valve spindle stem and the inner diameter of the valve guide, which allows deposits inside the guide (see figure 04). Due to this, MC-types need a replacement of the valve guide between 6,000 - 8,000 hrs to minimize the risk of the valve spindle sticking in the guide.

Figure 04b: Typical deposits of inner diameter of valve guide (MC70-type after 8,200 hrs)

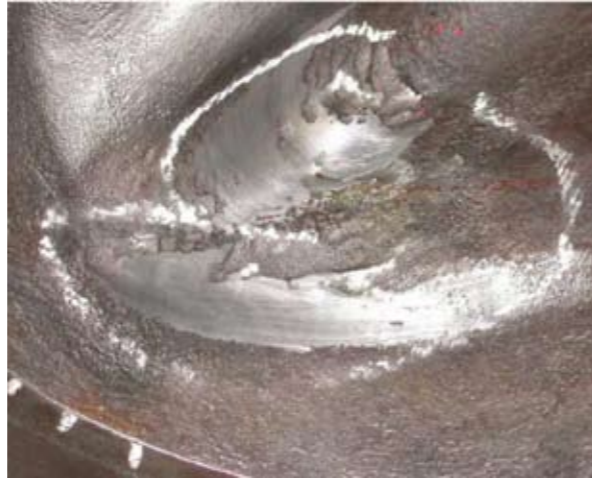
Heavy fuel contains high amounts of sulfur (up to 5%). If there is an exposed surface where the temperature is below the dew point of sulfuric acid, the acid condenses into liquid and can attack the metal surfaces. If a large amount of concentrated sulfuric acid condenses, it can attack the valve housing, bottom piece, valve guide and valve spindle stem. Sulfur acid has an extremely corrosive effect on cast iron (BEHRENS, GROTH 1990).

Figure 05: Low temperature corrosion of valve housing (MC-type 43,700 hrs)

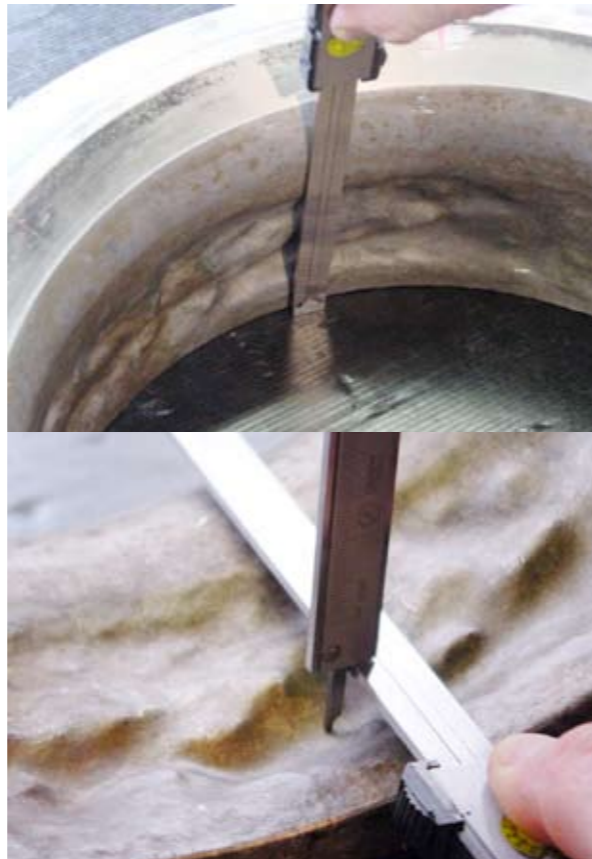
Figure 06: Low temperature corrosion of bottom piece (RTA-type after 28,420 hrs)

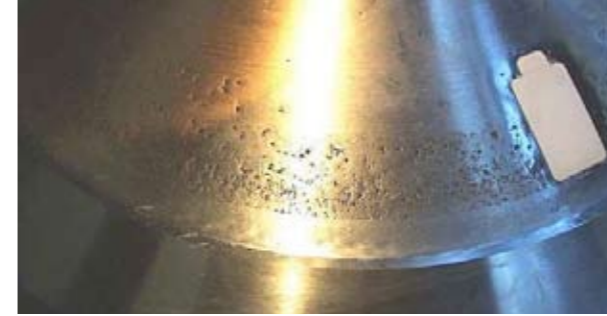
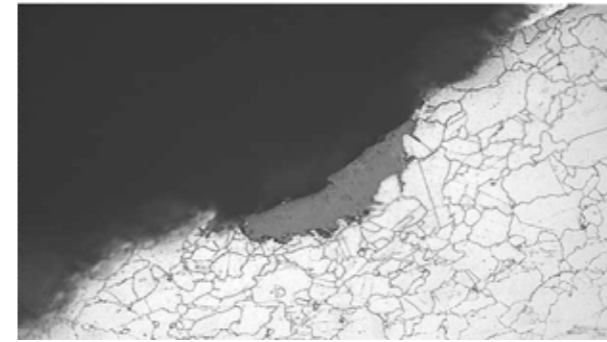
Figure 07: Low temperature corrosion (pitting corrosion attack) of under head radius of valve spindle (MC60-standard / 22,700 hrs)

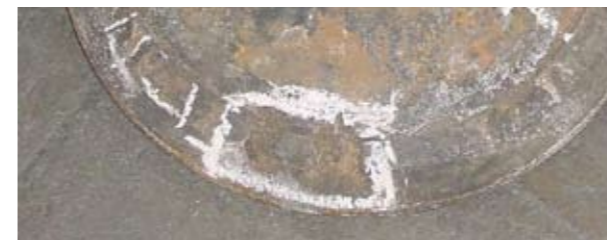
As a result of the above-mentioned physical process, the following wear mechanism can be described. Hard salt deposits on the seat surfaces of the valve spindle lead to dent marks caused by each closing stroke of the valve spindle. This can lead to crucial micro gas channels, which will grow over the time (NANDA, 2003). Because of the high temperature, the salt deposits reach their melting point, then the “cobble stone corrosion” starts (see figure 08) at the seat and finally leads to blow-byes (UMLAND 1975, RITZKOPF 1975). Result: The whole exhaust valve has to be replaced.

Figure 08: “Cobble stone corrosion” appearance of valve spindle failure through high-temperature corrosion (MC60 Standard-type)

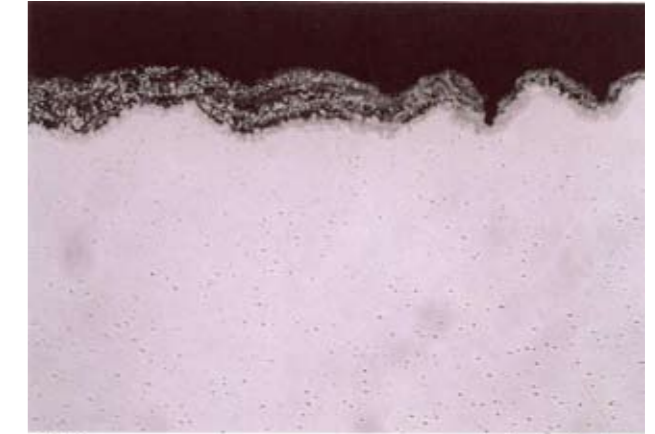
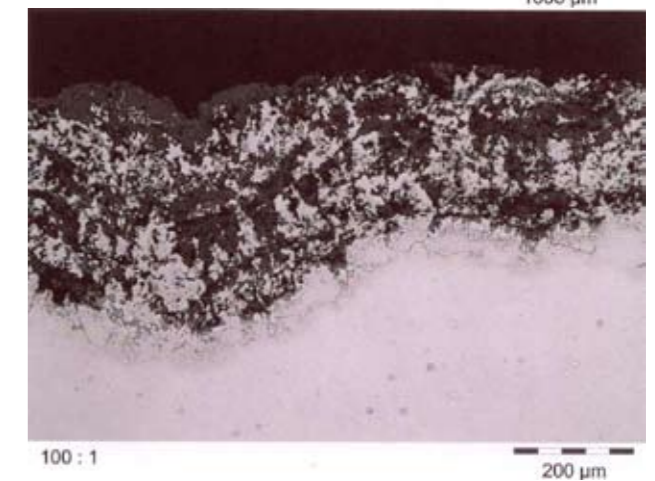
The bottom of the valve spindle is mostly operating in the critical area of the high-temperature corrosion seen as “cobble stone corrosion”. The wear rate is between 0,2 - 1,0 mm / 1,000 hrs. depending on valve material and type of engine. The limit for remanufacturing is only reached after 12 mm. This leads to a TBO of about 12,000 - 60,000 hrs. Figure 09 shows micro cuts of Nimonic with high-temperature corrosion.

Figure 09: Micro cuts of Nimonic with high-temperature corrosion.

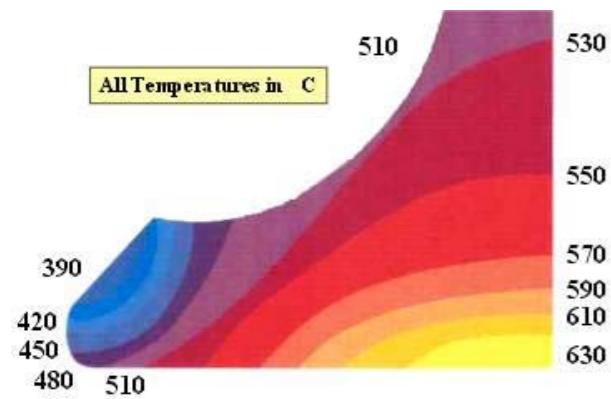
The valve spindle is the component with the maximum thermal stress. Most of fatigue problems are documented at the valve spindles. Figure 10 demonstrates a typical heat distribution across a Nimonic valve head.

Figure 10: Typical temperature distribution of a Nimonic exhaust valve head

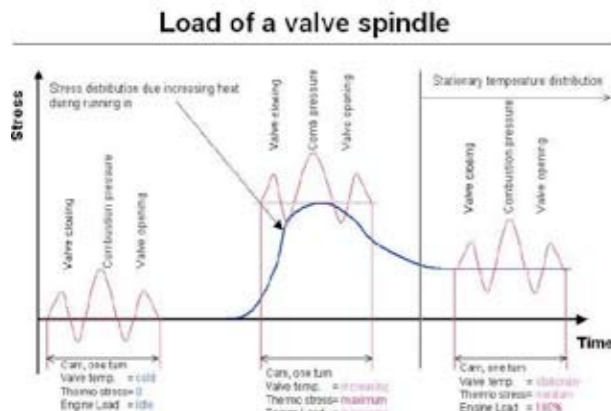
The maximum thermal stress takes place during the warm-up period. During this period the temperature at the center of the valve bottom and the seat reaches the maximum difference. Under regular operating conditions the temperature distribution is much lower. The mechanical load of a valve spindle is nearly constant between warm-up and regular operating, see figure 11.

Figure 11: Mechanical and thermal load as function of running in and stationary operation

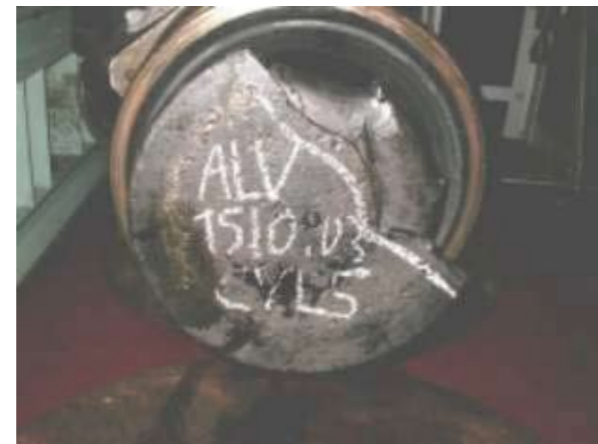
There are two typical failure reasons. One is a crack that starts in the under head radius. After the micro cracks get to a critical length, the speed of the crack growth increases. A catastrophic failure follows, with parts of the spindle dropping down into the combustion chamber (see figure 12 and 13).

Figure 12: Catastrophic failure of a repaired valve spindle (RTA72 Nimonic-type 740 hrs after repair)

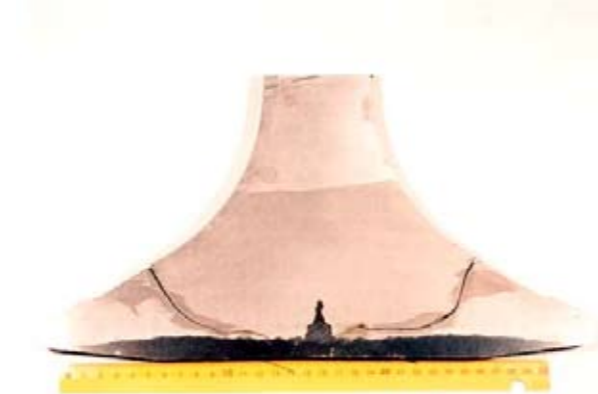
Figure 13: Macro cut through the center of a valve head (RTA62 Nimonic-type 6,430 hrs after repair)

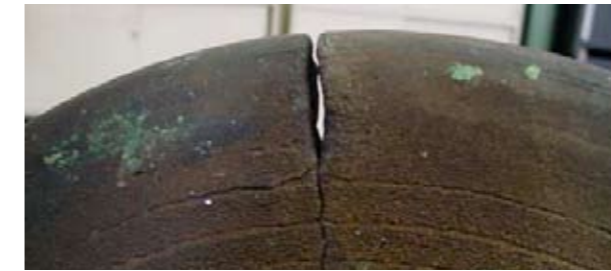
The second failure reason is: Micro cracks starting in the outer diameter of the valve bottom. After reaching the seat area blow-byes are created and the valve spindle is destroyed (see figure 14).

Figure 14: Failure of a valve spindle (RTA84 Nimonic type 5,270 hrs after repair).

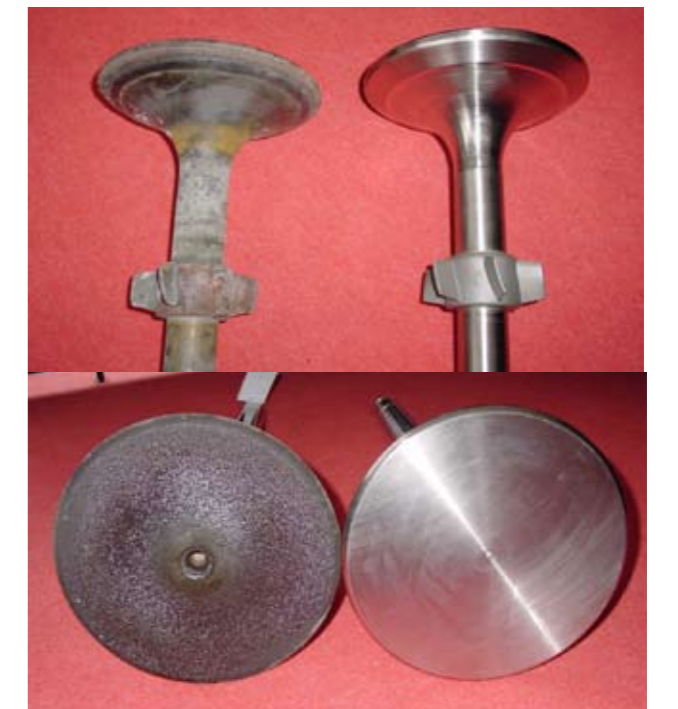
Nimalike is used in two ways: To extend the lifetime of a standard valve spindle to a lifetime similar to Nimonic, or to remanufacture Nimonic valve spindles in a way that leads to “close to new” conditions after the process (see figures 15 a/b).

Figure 15 a/b: Nimalike spindle before and after remanufacturing

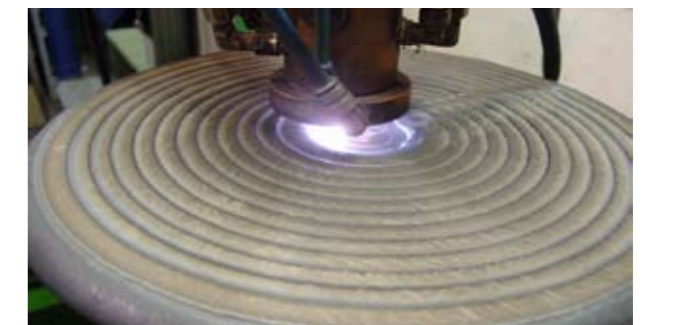
The competence to perform this remanufacturing method is a combination of long-time experience in the field and manufacturing technology. The experience is coupled with continuous improvement of manufacturing processes and intensive R&D in the fields of metallurgy and welding processes (see figure 16).

Figure 16: PTA-welding

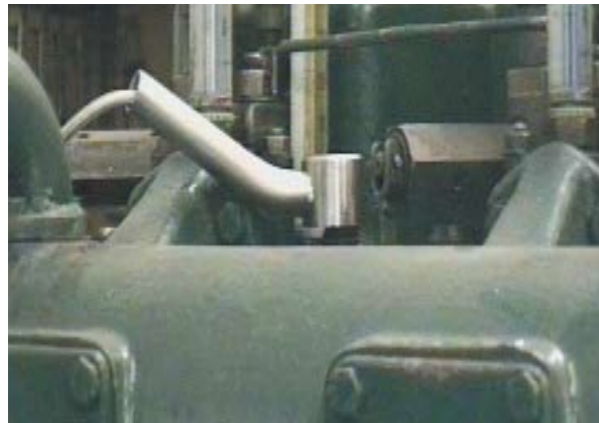
For this reason MWH provides the "Leakage Measure System", a mobile diagnostic system which is able to detect leakages at the cylinderhead to prevent fatal failures of a running engine. The principle is based on measurement of ultrasonic sound by using one simple and robust sensor (WEHNER, ALBERT 2001).

Figure 17: Leakage Measure System onboard in use

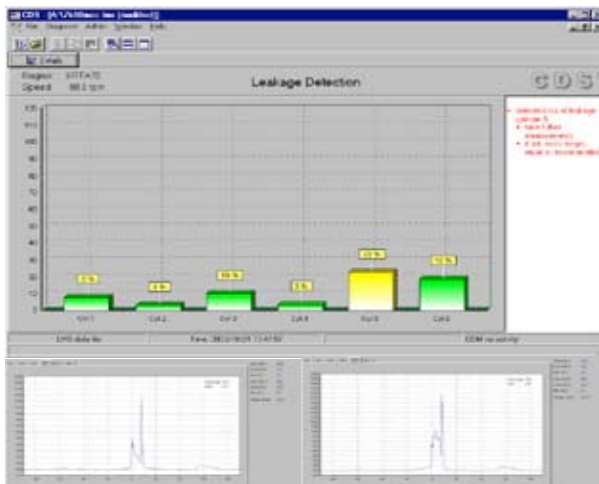
Figure 18: Documentation of the result of leakage detection and valvetiming/ignition

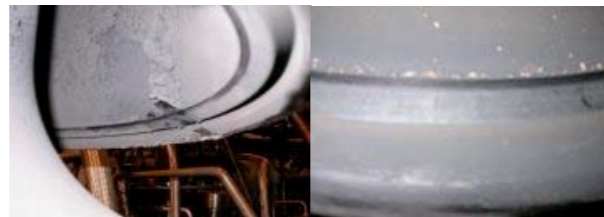
First field tests are ongoing with a MC70 engine. Inspections have proven that the Turnomat® works as designed (see figure 19).

Figure 19: Seat ring and valve spindle show no dent marks after app. 1,000 hours.

The valve rotator forces an accurate, reliable valve turning during valve closing. The Turnomat® principle is simple and surprisingly effective: The forced rotational movement causes a defined rotational energy for the valve at the instance of seating. This brings about the desired polishing effect, removing combustion deposits between valve spindle and valve seat and, at the same time, optimizing the heat exchange to the cooler valve seat.
