Welcome to the fourth issue of *Technical Matters*, a Lloyd's Register publication containing case studies covering technical issues and their solutions.

TECHNICAL MATTERS

June 2009

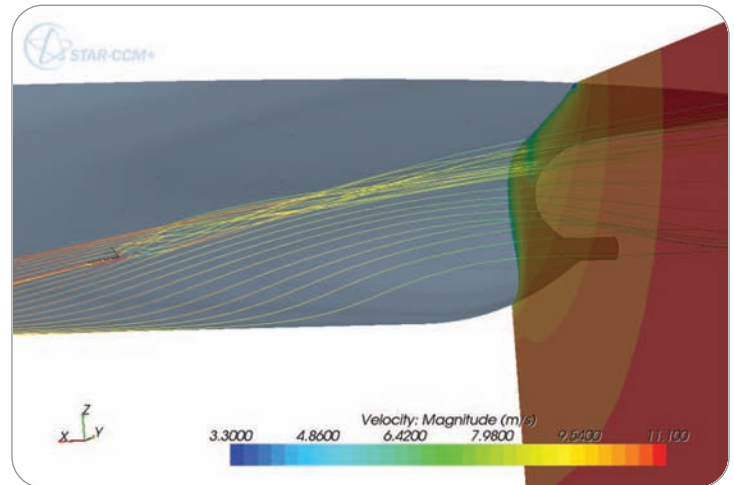
A common application of CFD methods is to improve the prediction of propeller inflows, i.e. ship wakes. These methodologies have been applied to a medium sized containership which suffered from high vibration and noise levels in the all-aft accommodation. To remedy the high vibration and noise levels, this ship was fitted with vortex generators to alter the inflow into the propeller.

The result was a reduction in hull pressures radiated from the collapsing sheet and tip vortex cavitation on the propeller.

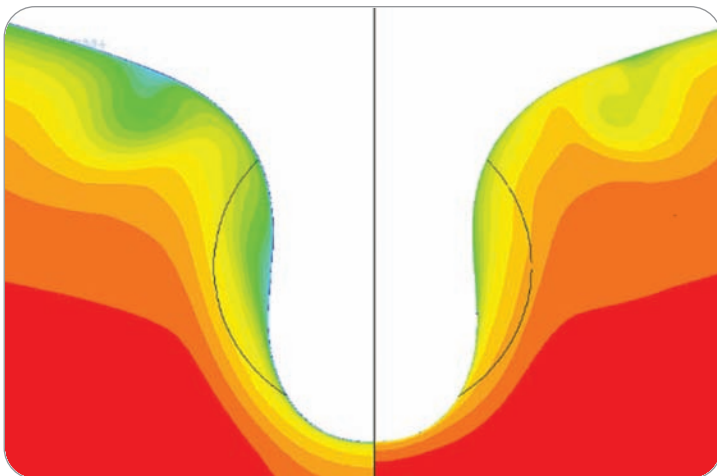
Two CFD models were analysed: one with, and one without vortex generators added. It was found that with addition of the vortex generators a reduction in propeller inflow velocities near top dead centre was achieved, as desired. The vortex generator was also found to reduce the axial velocity elsewhere in the propeller disc.

CFD analysis allows detailed examination of flow features that would not be possible using model tests. The flow can be visualised in various ways such as viewing of the vorticity in the wake and examination of streamlines around the dynamic ship form.

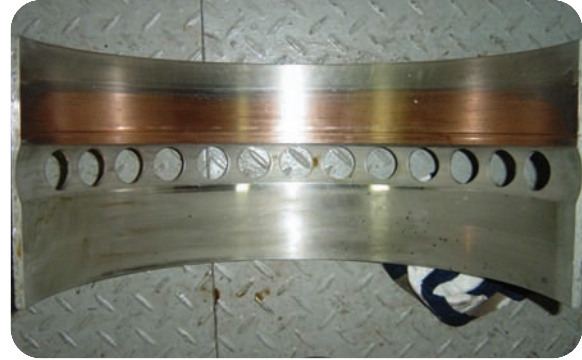
A small container ship had problems with its main engine driven lubricating oil system since construction. There were three separate failures of the two lubricating oil pumps. In each incident, one of the lubricating oil pumps failed catastrophically. The principal damage caused was the failure of a number of the connecting rod bottom end bearings. After each failure a large amount of both fine and coarse metal debris was found in the oil filtration system. Lloyd's Register Technical Investigations (TI) was asked to attend the vessel to investigate and advise.

Prior to each failure the lubrication oil pressure was reported to have fluctuated rapidly. Such a characteristic is often indicative of air pockets travelling through the oil suction system.

A number of problems were identified, including:

- aerated oil being delivered to the pump suction pipes due to the pump suction and engine discharge pipes being in close proximity;
- the accumulation of air in the suction system due to pipe geometry;
- contamination of the lubricating oil with fine metal particles possibly extending back to original construction.

An extensive range of modifications were made to the sump tank and the off-engine lubricating oil pipework system. A thorough cleaning of the entire system was also carried out to remove all metal debris.

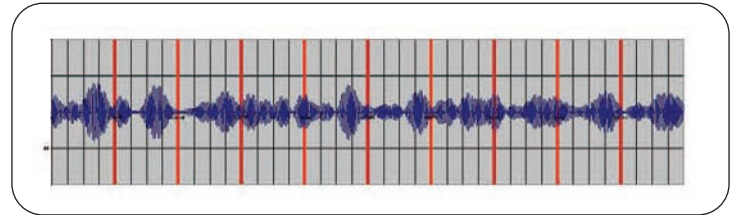
The reported nature of the noise strongly suggested a type of propeller cavitation as the primary source and hence sea trials were organised in order to define the noise and cavitation characteristics in both the load and ballast conditions.

Borescope observations of flow at the duct exit plane showed variable length sections of a strong cavitating tip vortex emerging from the duct at shaft rate. Tip vortex cavitation structures were also observed within the duct, some disintegrating. Audio and video recordings showed a correspondence between the dominant collapse of the tip vortex emerging from the duct.

This was the first known case of a once per revolution broadband noise source which was not from a "singing propeller". It was concluded that dimensional variations on the propeller and duct may have led to the formation of the strong cavitating vortex. Recommendations were made to survey the other ships and to pay close attention to the blade inspection process, assembly and installation inside the ducts.

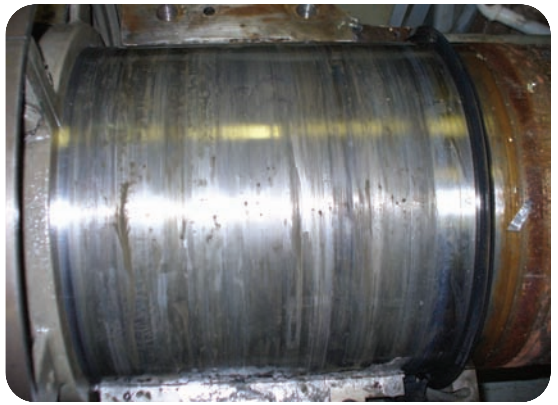
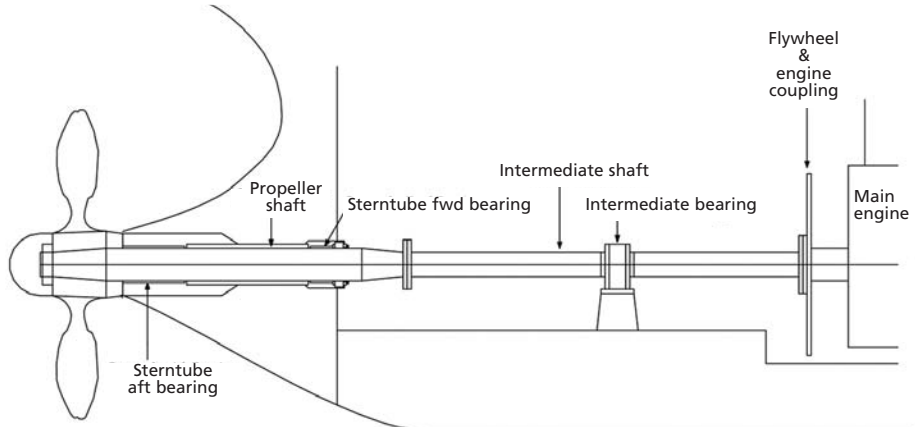
During a partially laden voyage a direct drive diesel powered Chemical Tanker suffered a severe failure of the intermediate shaft pedestal bearing. Significant wiping damage occurred to the bearing white metal surface requiring the ship to be towed to port for repair.

load along the shafting system length. In particular it was found that the forward sternbush and the second aft engine bearing had insufficient downwards load. The second aft engine main bearing was considered to be at risk of fatigue damage.

It was found by calculation that the satisfactory operation of the shafting system could be achieved even though the forward sternbush was only lightly loaded. This was supported by recent operating experience.

Calculations revealed that the scope for improvement of the alignment conditions by adjustment of the intermediate bearing was limited. Loading of the engine second aft main bearing by fitting an upwards offset bearing shell was therefore recommended. Such adjustment would improve the loading on the engine bearing but would have negligible effect at the forward sternbush.

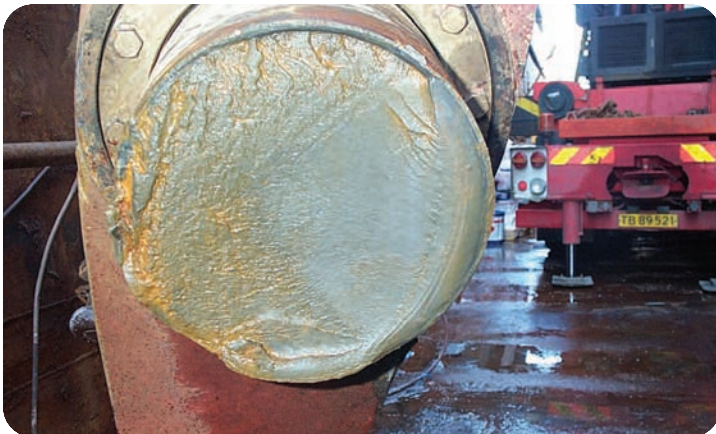
After three years in service one of the stabilisers was found to be missing, having failed due to fatigue some time before.

By examining the remaining part of the fatigued stabiliser stock at the Lloyd's Register Materials and NDE Laboratory it was found that a fatigue crack had grown from a single initiation point, 5 mm below the shaft surface, in the fusion zone between a weld and the base material. Welded regions often show characteristic non-uniformities and inclusions at the base material interface. It was also found that no heat treatment had been undertaken to eliminate residual stresses. These residual stresses can often encourage crack growth.

shaft due to roll of the ship in service. The low factor of safety was apparent from the fatigue pattern as the fatigue crack had propagated for only 15% of the shaft diameter before rapid brittle fracture finally occurred.

During the initial stages of crack growth there were three distinct bands of relatively slow propagation interspersed with two narrow bands of more rapid propagation. These changes in crack growth rate indicated significant changes in service loading, such as loading induced by especially rough sea conditions.

Recommendations were made that the stabiliser stocks on sister vessels should be examined visually and by non-destructive testing for the presence of cracks. Recommendations were also given to fitting shafts with an increased operating margin against imposed bending loads.

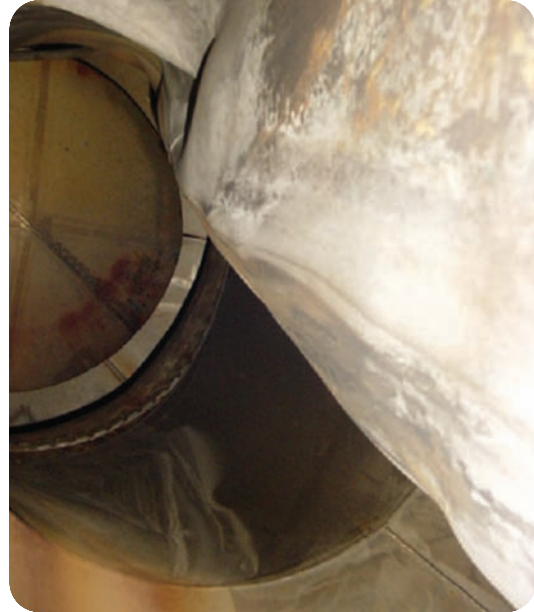
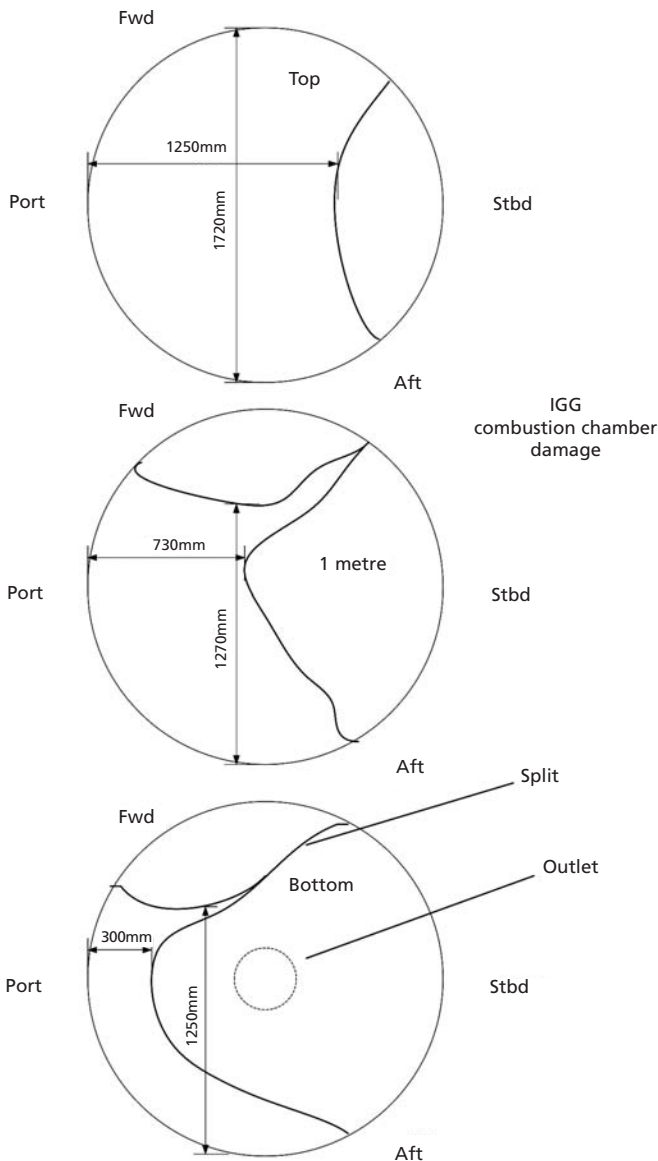
Following the collapse of an Inert Gas Generator (IGG) furnace onboard a LNG carrier an investigation was carried out into how the controls and instrumentation could have allowed the failure to occur.

The inert gas and effluent pressures were compared using a Proportional Integral (PI) controller which controlled the position of the effluent valve. It was found that the two pressure transducers of the PI controller were both blocked with debris, giving false readings, therefore causing the effluent valve to be incorrectly positioned. At the time of the furnace collapse the valve was found to be fully closed.

The combustion chamber flooded causing the Level Shut Down Alarm to operate. The alarm appeared to have tripped the ballast pump but not the burner flame. The resulting shortage of water to the lit furnace caused overheating of the combustion chamber wall which yielded and collapsed.

The Temperature Shut Down Alarm did not detect the rise in temperature of the combustion chamber wall due to its remote location from the point of failure.

A number of recommendations were made to modify the method and manner by which the system shut off the burner if the cooling water were to be reduced or blocked. It was also recommended to include a mechanical fail safe device which would allow the continued flow of cooling water if the effluent valve were to close at an inappropriate moment.

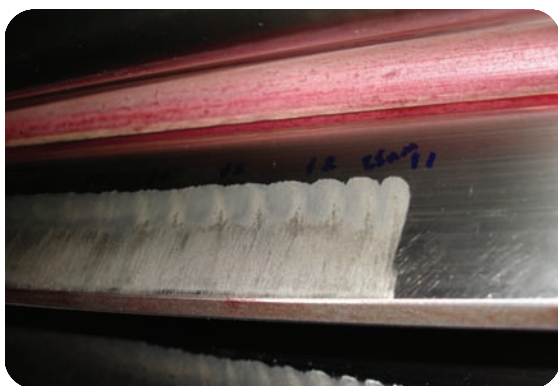
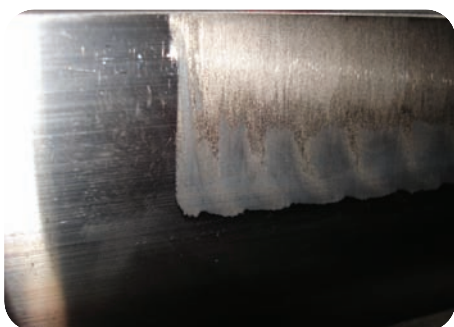
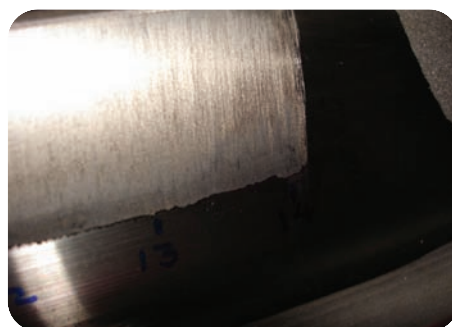
Severe scuffing damage occurred on the teeth of the two input pinions and main wheel of the main propulsion gearing during trials of a newly built diesel electric LNG carrier. The propulsion system consists of twin electric motors driving a single output main propulsion shaft and fixed pitch propeller through single reduction, single-helix gears. Lloyd's Register Technical Investigations (TI) was asked to attend onboard at the newbuilding yard to inspect the tooth flank damage and assist with the failure investigation.

Failure of the gears was traced from trial records to occurring during a rapid acceleration test. In this test, the propulsion plant was accelerated from stationary to full away in a little over eleven minutes.

The scuffing damage was due to a breakdown of the elasto-hydrodynamic oil film which should normally be present between mating gear teeth. The breakdown resulted from a combination of the selection of the pinion gear tooth-end design and the rapid rate of torque input to the pinion gears from the electric propulsion motors. It was considered likely that the damage was initiated at the starboard mesh and then transferred to the port mesh in way of the main wheel.

The damaged pinion gears were returned to the gearing manufacturer for remedial

machining including design modifications to the gear tooth flank. The main wheel tooth flanks were polished in-situ.

Following repair, the reduction gearing successfully completed sea trials. This was achieved by modifying the pinions helix correction and end relief. The propulsion electric motor speed-torque characteristics had also been modified to reduce the initial rate of torque delivery to the pinion gears.

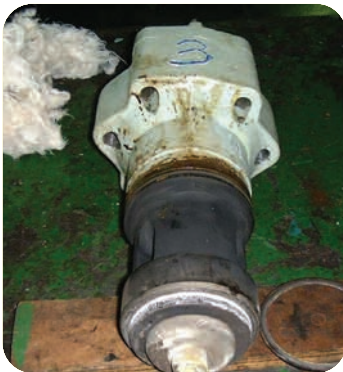
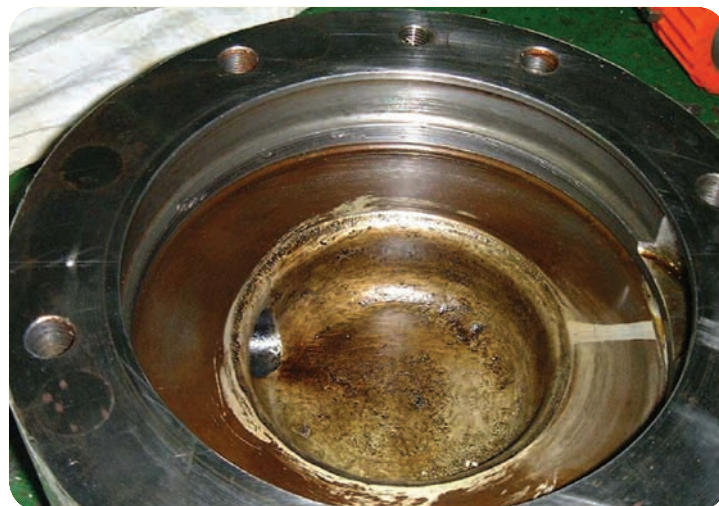
During testing of the stop-start function of an oil tanker main diesel engine an explosion in the main starting air manifold was experienced. Damage was sustained to the manifold itself, the automatic valve and the inlet pipe to a cylinder unit. The explosion occurred on two separate occasions before Lloyd's Register Technical Investigations (TI) was called in to determine the cause.

- the air start valves fitted to the engine had air leaks in all valves in way of the valve seat:
- the starting air manifold and the air inlet pipes had an internal coating of a black oily/sooty substance (consistent with the physical characteristics often found after an explosion). Oil sludge deposits were removed from the air start manifold and sent for analysis, proving that the source of the oil contamination was the main air compressor lubricating oil:

It was found that the air distributor, which provides the timing for opening the air start valves, was worn excessively by the ingress of hard foreign objects. The wear allowed air to enter unintended air start pilot lines, opening both correct and incorrect air start valves. Firing from the main engine cylinder had then allowed an ignition source into the air start

manifold, igniting the mist and oil deposits and hence causing the explosions.

The system was repaired by replacement of the air distribution system along with machining and lapping of the air start valve seat. The air start manifold, piping and associated machinery were also thoroughly cleaned. Recommendations were also made to overhaul the main air compressor lubrication system, to prevent the air start manifold becoming contaminated with lubricating oil.

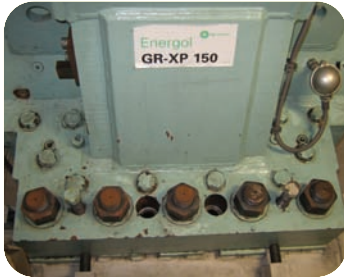
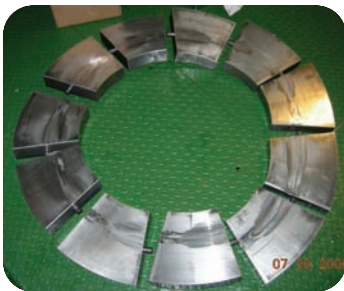
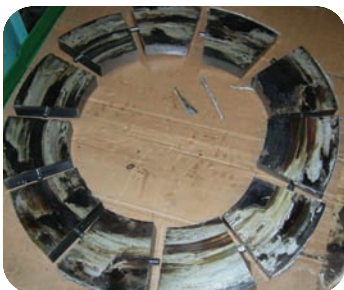
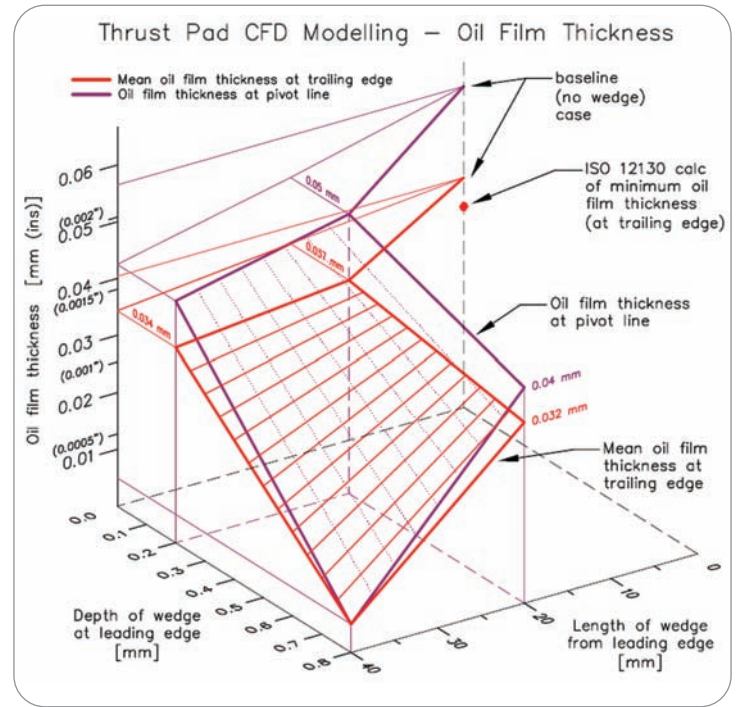
A twin screw diesel electric oil tanker experienced repeated failures of the starboard shaftline axial thrust bearing. The two sets of propulsion shafting consisted of an electric motor directly coupled to a thrust shaft, intermediate shaft, propeller shaft, and fixed pitch propeller. Each thrust shaft was supported by oil lubricated white metal bearings each side of the thrust collar with the ahead and astern thrusts taken by eleven tilting pads each side of the collar. Overheating and wiping of the white metal of the tilting pads occurred on three separate occasions early in the life of the vessel.

At the same time, the design and operation of the tilting pad elements was investigated using Computational Fluid Dynamics (CFD). Modelling was carried out to investigate the effect of varying the oil viscosity, the operating temperature and different designs of leading edge geometry on the bearing oil film thickness. The minimum thickness at service speed was estimated to be 32 microns (0.032 mm).

The cause of the failure was eventually identified using a simple mechanical dial-gauge indicator. Relative movement between the upper and lower thrust block casing halves was occurring as a result of loosening of the holding-down bolts. The unequal reactions in the upper and lower casings overloaded thrust pads which reduced the oil film thickness and resulted in overheating and failure.

Recommendations were made to replace the existing thrust block holding-down bolts with hydraulically tightened, expanding sleeve type bolts.
